**MERCEDES C BERLINE: 1KXU210**

**Limited Technical Inspection**

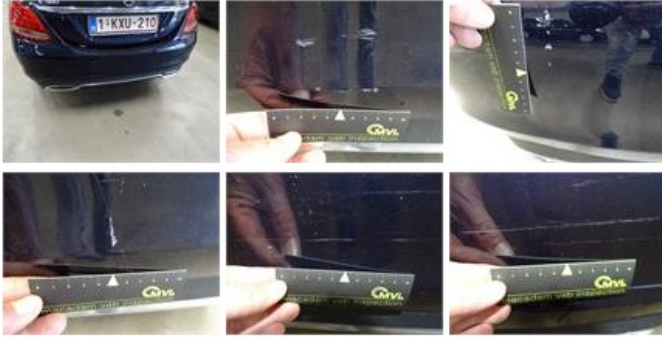
Bumper R, Scratch(es), LI - Repair and paint (complete)	211,80
---------------------------------------------------------	--------
