**AUDI A4 AVANT: 1KXH773**

**Limited Technical Inspection**

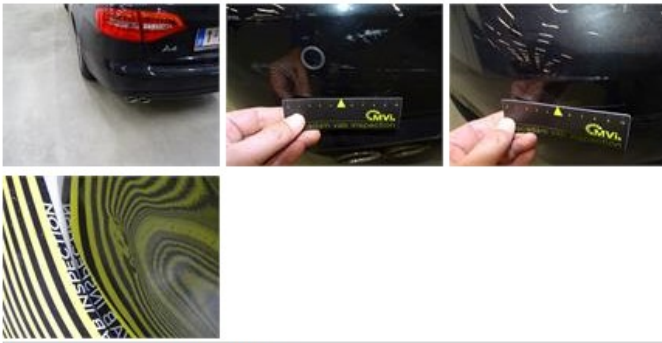
<b>Total cost ex VAT</b>	<b>1491,00</b>
<b>Bumper R, Dent(s) and scratch(es), LI - Repair and paint (complete)</b>	<b>211,80</b>
