## AUDI A6 AVANT: 1KUF825

## Limited Technical Inspection

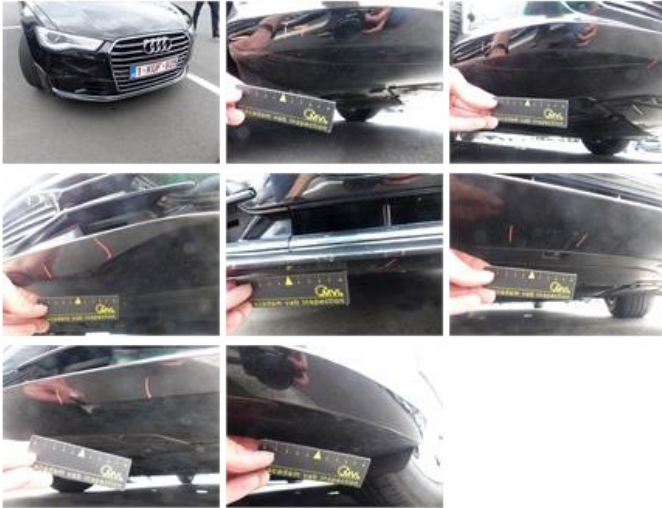
Alloy rim R R, Scratch(es), Acceptable	0,00
<i>No pictures to display</i>	
Seat F L compl, Worn, Acceptable	0,00
<i>No pictures to display</i>	
Bumper R, Scratch(es), Acceptable	0,00
<i>No pictures to display</i>	
Wing R L, Scratch(es), Acceptable	0,00
<i>No pictures to display</i>	
Bumper F, Scratch(es), It - Spot repair	115,56

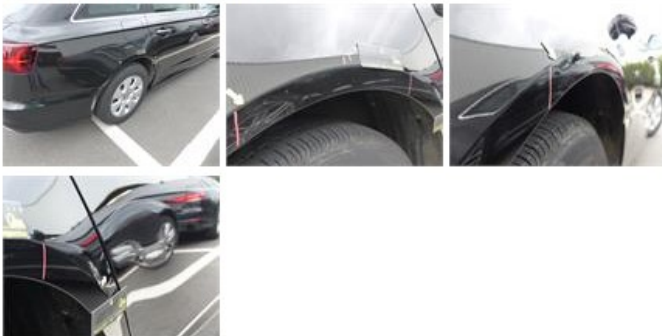
Alloy rim R L, Scratch(es), Acceptable	0,00
<i>No pictures to display</i>	
Door R R, Scratch(es), Acceptable	0,00
<i>No pictures to display</i>	
Rearview mirror housing R, Scratch(es), Acceptable	0,00
<i>No pictures to display</i>	
Door R L, Dent(s) and scratch(es), Acceptable	0,00
<i>No pictures to display</i>	
Alloy rim F R, Scratch(es), Acceptable	0,00
<i>No pictures to display</i>	
Wing R R, Scratch(es), It - Spot repair	115,56
