## VOLKSWAGEN PASSAT VARIANT: 1THF233

## Limited Technical Inspection

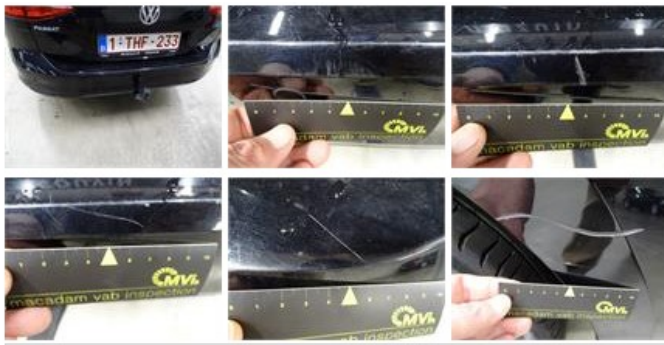
Total cost ex VAT	1209,55
Door F L, Scratch(es), Acceptable	0,00
<i>No pictures to display</i>	
Bumper R, Scratch(es), LI - Repair and paint (complete)	211,80

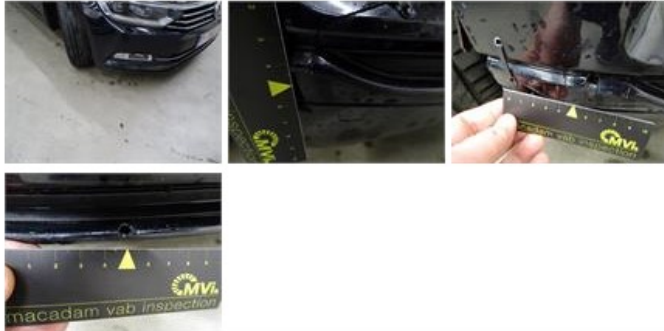
Bumper F, Crack, Le - Replace and paint

0,00
