VOLKSWAGEN GOLF VARIANT: 1PFC786

Limited Technical Inspection

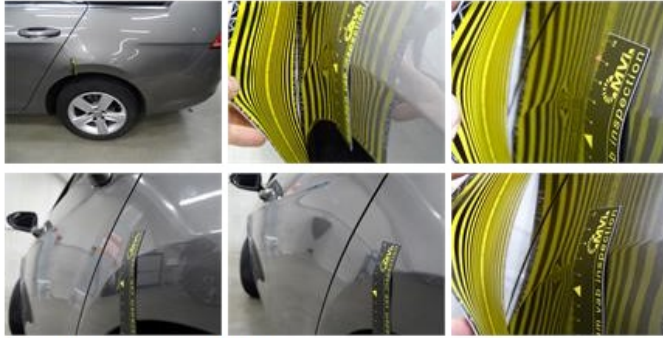
Tailgate, Dent(s), Acceptable	0,00
<i>No pictures to display</i>	
Alloy rim F L, Scratch(es), Acceptable	0,00
<i>No pictures to display</i>	
Wing F R, Dent(s) and scratch(es), Acceptable	0,00
<i>No pictures to display</i>	
Alloy rim R R, Scratch(es), Acceptable	0,00
<i>No pictures to display</i>	
Wing R L, Dent(s), PDR - Paintless dent repair	63,00

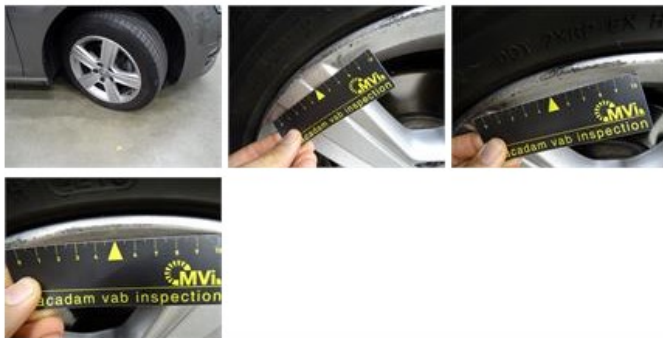
Door F L, Scratch(es), Acceptable	0,00
<i>No pictures to display</i>	
Door F R, Scratch(es), Acceptable	0,00
<i>No pictures to display</i>	
Alloy rim F R, Scratch(es), LI - Repair and paint (complete)	95,00

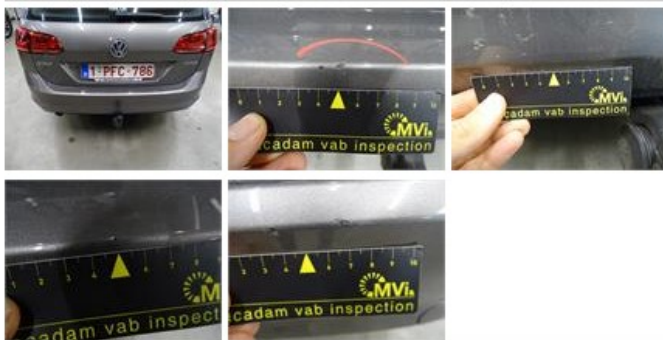
Bumper R, Scratch(es), LI - Repair and paint (complete)	211,80
---	--------
