VOLKSWAGEN TIGUAN: 1LBD572

Limited Technical Inspection

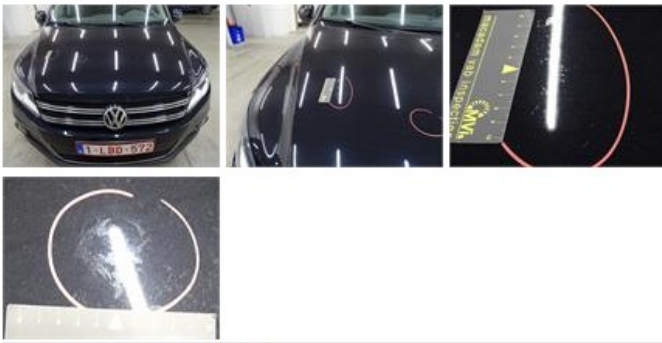
Total cost ex VAT	290,08
Door F L, Scratch(es), Acceptable	0,00
<i>No pictures to display</i>	
Rearview mirror housing R, Scratch(es), 67 - Polish	0,00
<i>No pictures to display</i>	
Door F R, Scratch(es), Acceptable	0,00
<i>No pictures to display</i>	
Bonnet, Chemical pollution, LI - Repair and paint (complete)	290,08
