BMW SERIE 5: 1LBY303

Limited Technical Inspection

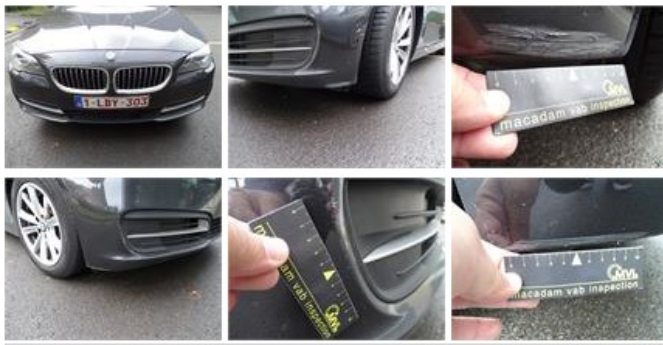
Bumper F, Scratch(es), LI - Repair and paint (complete)	254,16
---	--------

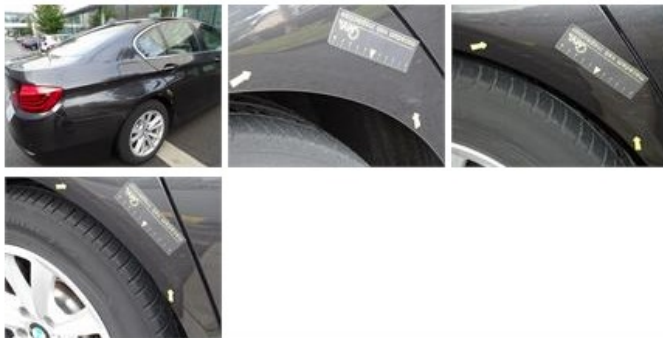
Seat cover R, Stain, Acceptable	0,00
<i>No pictures to display</i>	
Door F R, Dent(s) and scratch(es), Acceptable	0,00
<i>No pictures to display</i>	
Alloy rim F R, Scratch(es), Acceptable	0,00
<i>No pictures to display</i>	
Door R R, Scratch(es), Acceptable	0,00
<i>No pictures to display</i>	
Wing R R, Dent(s) and scratch(es), LI - Repair and paint (complete)	417,84
