**BMW 3 GRAN TURISMO: 1LDA627**

**Limited Technical Inspection**

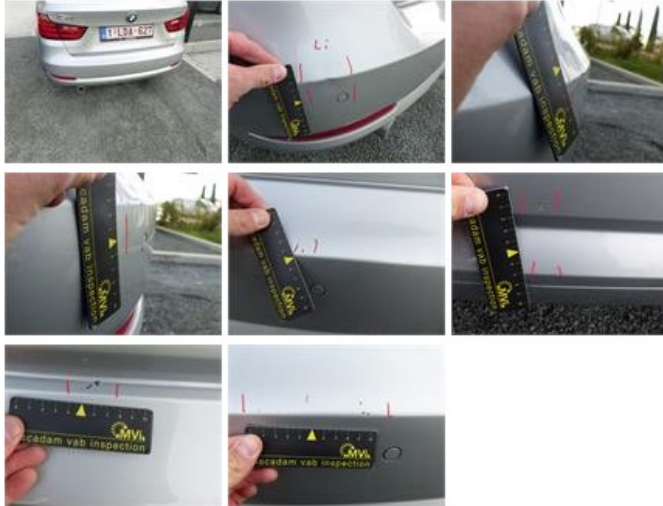
<i>No pictures to display</i>	
Door F L, Dent(s) and scratch(es), Acceptable	0,00
<i>No pictures to display</i>	
Alloy rim R R, Scratch(es), Acceptable	0,00
<i>No pictures to display</i>	
Outer backrest protection R, Scratch(es), Acceptable	0,00
<i>No pictures to display</i>	
Trunk lid covering R, Scratch(es), Acceptable	0,00
<i>No pictures to display</i>	
Seat F L compl, Worn, Acceptable	0,00
<i>No pictures to display</i>	
Bumper R, Dent(s) and scratch(es), LI - Repair and paint (complete)	211,80

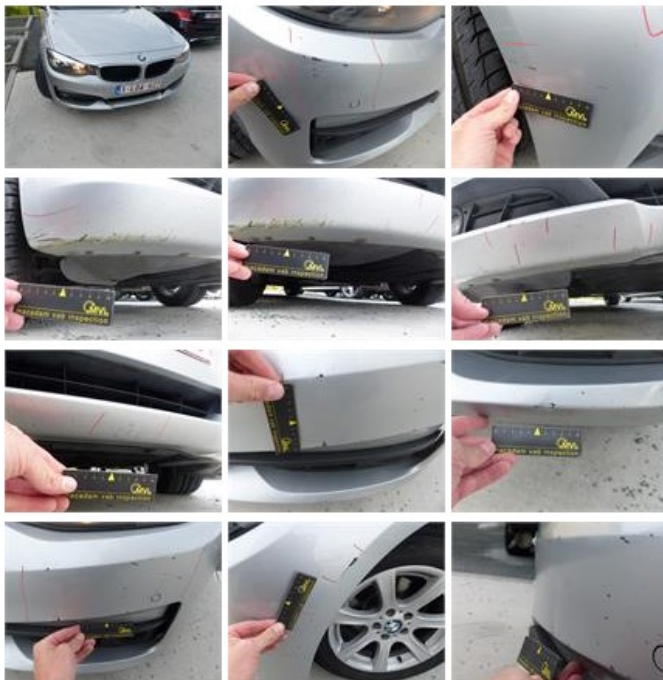
Internal Boot Lining R, Scratch(es), Acceptable	0,00
<i>No pictures to display</i>	
Alloy rim R L, Scratch(es), Acceptable	0,00
<i>No pictures to display</i>	
Windscreen, Stone chip(s), Acceptable	0,00
<i>No pictures to display</i>	
Bumper F, Dent(s) and scratch(es), LI - Repair and paint (complete)	211,80

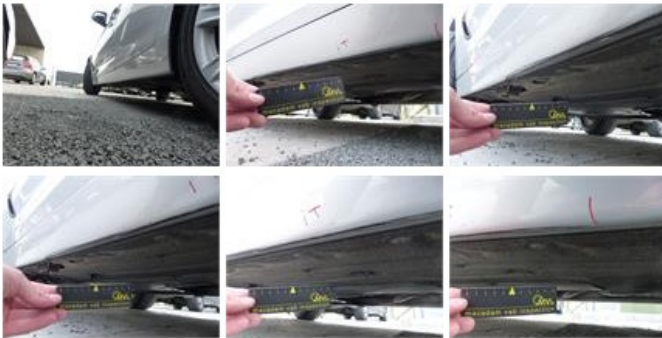
Sill trim L, Scratch(es), It - Spot repair 115,56
