BMW 4 GRAN COUPE: 1RVL438

Limited Technical Inspection

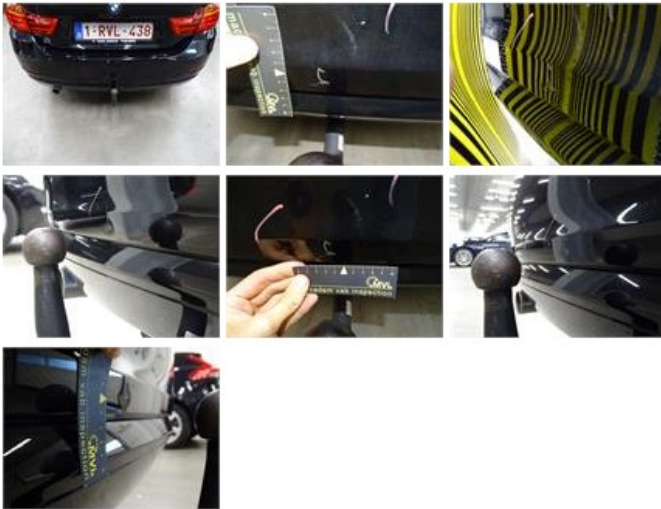
Tailgate, Dent(s) and scratch(es), Acceptable	0,00
<i>No pictures to display</i>	
Door R L, Scratch(es), Acceptable	0,00
<i>No pictures to display</i>	
Roof, Chemical pollution, Acceptable	0,00
<i>No pictures to display</i>	
Door F L, Scratch(es), Acceptable	0,00
<i>No pictures to display</i>	
Bumper R, Dent(s) and scratch(es), LI - Repair and paint (complete)	254,16
