MERCEDES C BREAK: 1LCN266

Limited Technical Inspection

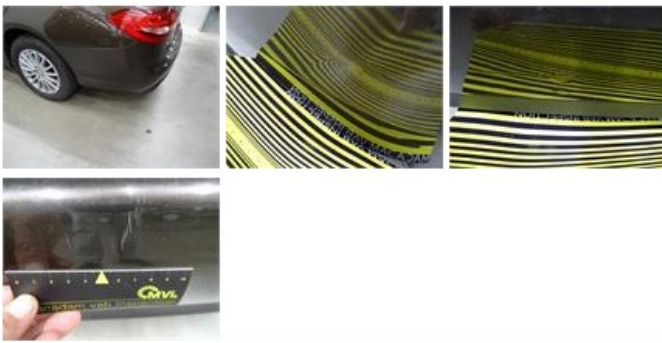
Total cost ex VAT	634,16
Wing F L, Scratch(es), Acceptable	0,00
<i>No pictures to display</i>	
Bumper R, Dent(s) and scratch(es), LI - Repair and paint (complete)	211,80

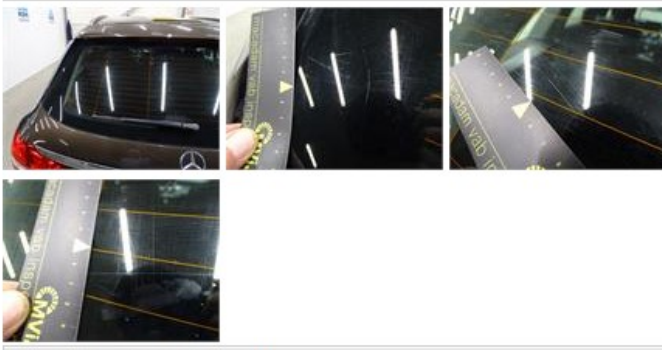
Tailgate, Scratch(es), Acceptable	0,00
<i>No pictures to display</i>	
Rear window, Scratch(es), E - Replace	0,00

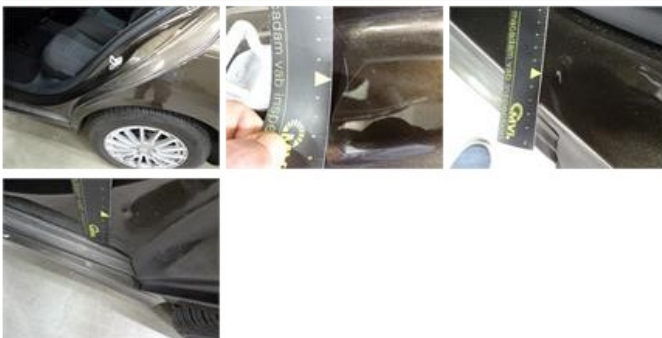
Door F L, Scratch(es), Acceptable	0,00
<i>No pictures to display</i>	
Door F R, Scratch(es), Acceptable	0,00
<i>No pictures to display</i>	
Wing R L, Dent(s) and scratch(es), It - Spot repair	115,56

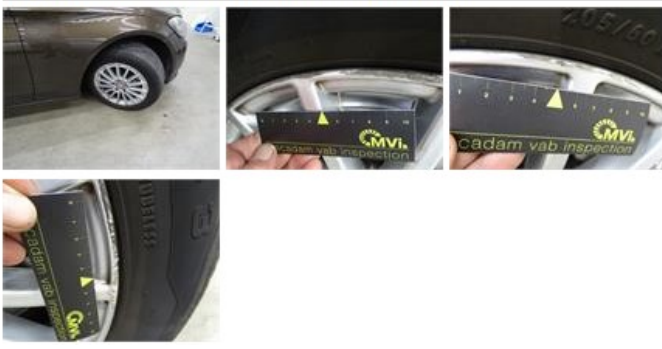
Alloy rim F R, Scratch(es), LI - Repair and paint (complete)	95,00
--	-------
