**MERCEDES CLA SHOOTING BRAKE: 1KLE250**

**Limited Technical Inspection**

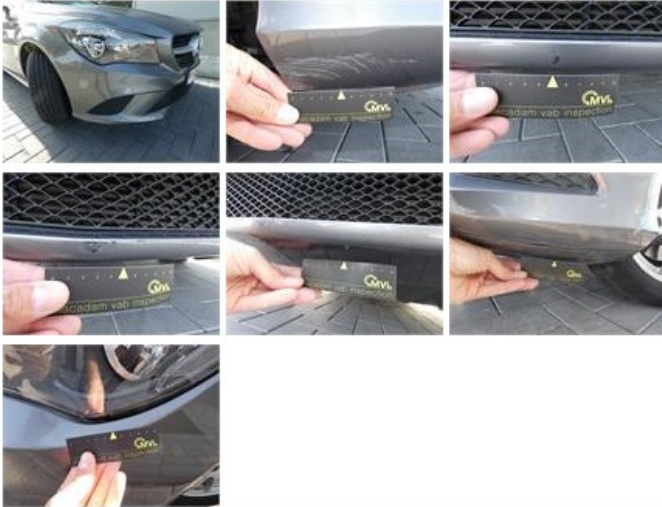
<i>No pictures to display</i>	
Windscreen, Stone chip(s), Acceptable	0,00
<i>No pictures to display</i>	
Alloy rim R L, Scratch(es), Acceptable	0,00
<i>No pictures to display</i>	
Roof, Dent(s), Acceptable	0,00
<i>No pictures to display</i>	
Bumper F, Scratch(es), LI - Repair and paint (complete)	211,80
