VOLVO V40: 1GVJ981

Limited Technical Inspection

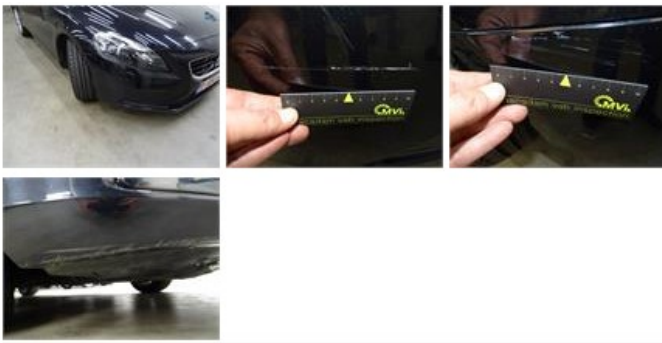
Total cost ex VAT	496,80
Wing F L, Dent(s), Acceptable	0,00
<i>No pictures to display</i>	
Bumper F, Scratch(es), LI - Repair and paint (complete)	211,80

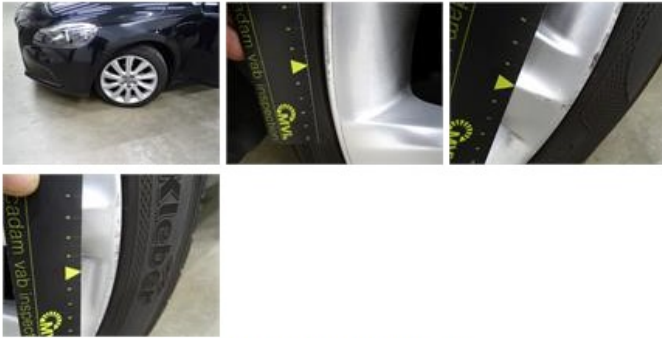
Alloy rim F L, Scratch(es), LI - Repair and paint (complete) 95,00
