## VOLVO V40: 1HGZ875

## Limited Technical Inspection

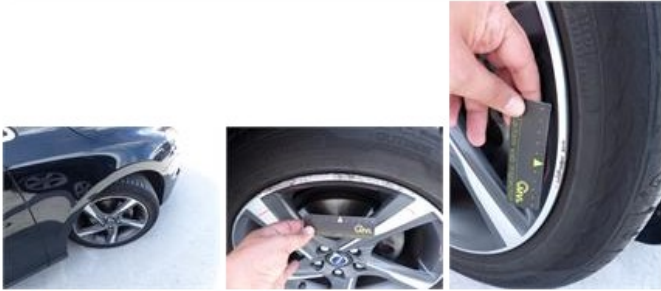
Door R L, Dent(s), Acceptable	0,00
<i>No pictures to display</i>	
Alloy rim F R polished, Scratch(es), LI - Repair and paint (complete)	95,00
