CITROEN C4 Picasso: 1HTP588

Limited Technical Inspection

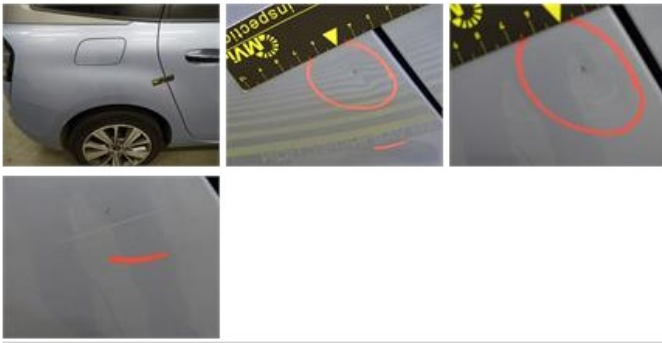
Compressor	Yes
Total cost ex VAT		548,76
Alloy rim F L polished, Scratch(es), Acceptable		0,00
<i>No pictures to display</i>		
Bumper F, Scratch(es), Acceptable		0,00
<i>No pictures to display</i>		
Wing R R, Dent(s) and scratch(es), LI - Repair and paint (complete)		308,20
