PEUGEOT 308: 1HGVT36

Limited Technical Inspection

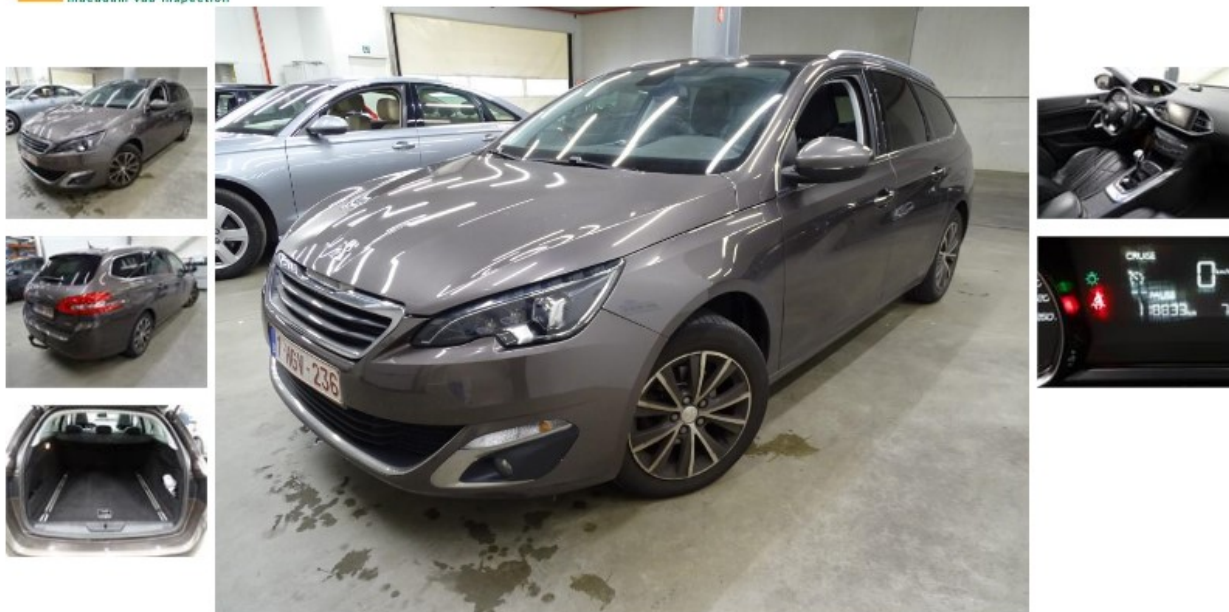
Vinnumber:	VF3LCBHXHES173076	Versionname:	308 SW BlueHDi Allure STT 116PK
First Registrationdate:	17/07/2014	Fiscalpower:	
Expertise Mileage:	118833	Power Kw:	85
Bodytype:		Body color:	Dark Brown
Gearbox:	MAN 6 VIT	Paint type:	Metalic
Transmission:	Front	Rims summer:	Aluminium
Fueltype:	Diesel	Oil level:	OK
Battery functioning:	Yes	Parking lot:	1328
Number of doors:	5		
Number of seats:	5		
Number head rests:	5		
Rims summer:	Aluminium		
Category:	Passenger Car		
Oil level:	OK		
Registration Certificate Car (BE):	Yes
