RENAULT MEGANE GRANDTOUR: 1LLH703

Limited Technical Inspection

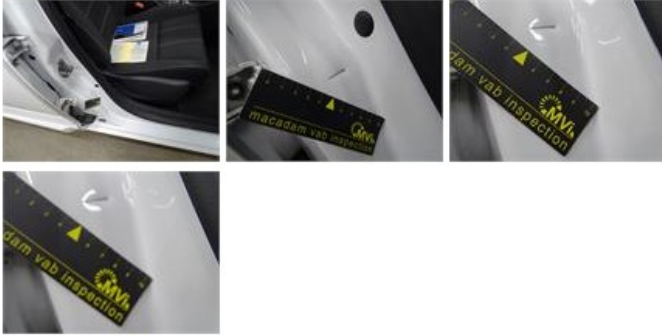
Bodywork, Not original part, Acceptable	0,00
<i>No pictures to display</i>	
Door F L, Scratch(es), Acceptable	0,00
<i>No pictures to display</i>	
Wheel cover R R, Scratch(es), Acceptable	0,00
<i>No pictures to display</i>	
Tailgate, Scratch(es), Acceptable	0,00
<i>No pictures to display</i>	
Rocker panel inner F R, Dent(s), LI - Repair and paint (complete)	115,56
