**SEAT IBIZA ST: 1NRF256**

**Limited Technical Inspection**

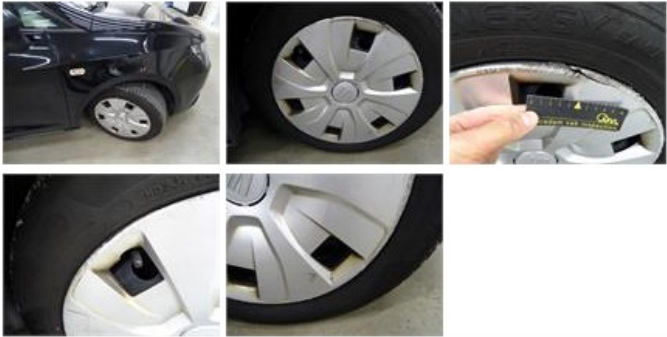
Bumper R, Scratch(es), Acceptable	0,00
<i>No pictures to display</i>	
Rear window, Scratch(es), Acceptable	0,00
<i>No pictures to display</i>	
Door R L, Scratch(es), Acceptable	0,00
<i>No pictures to display</i>	
Door F L, Scratch(es), 67 - Polish	0,00
<i>No pictures to display</i>	
Door F R, Scratch(es), Acceptable	0,00
<i>No pictures to display</i>	
Wheel cover F R, Deformed / Strained, E - Replace	30,00
