PEUGEOT 308 SW: 1LEL977

Limited Technical Inspection

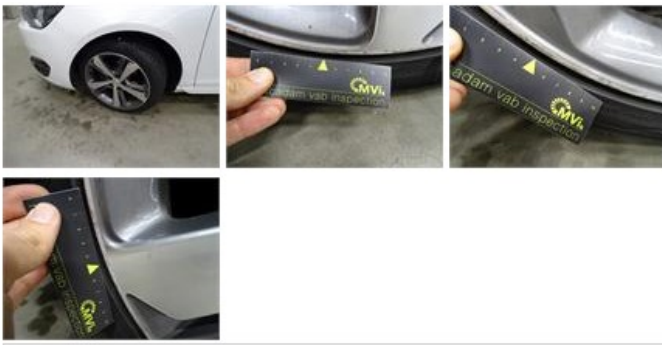
Total cost ex VAT		560,00
Bumper R, Scratch(es), Acceptable		0,00
<i>No pictures to display</i>		
Alloy rim F L polished, Scratch(es), LI - Repair and paint (complete)		95,00

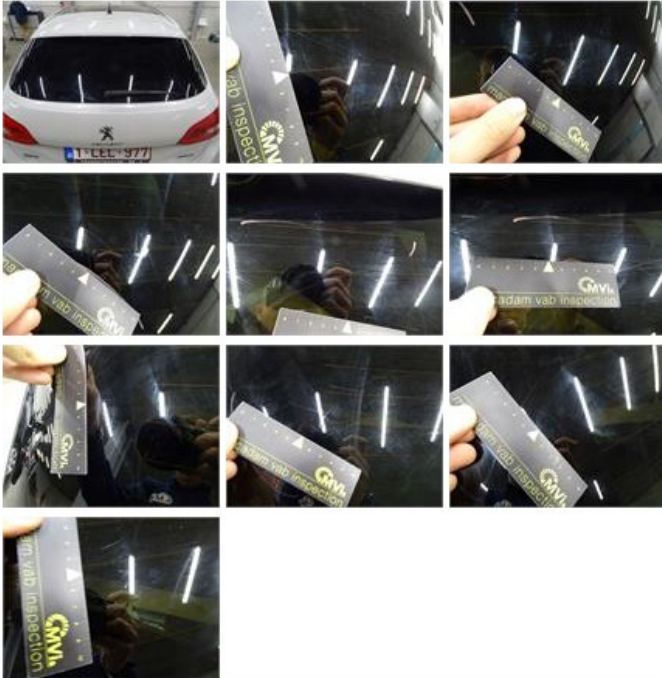
Rear window, Scratch(es), E - Replace 370,00
