**CITROEN Berlingo: 1BNM523**

**Limited Technical Inspection**

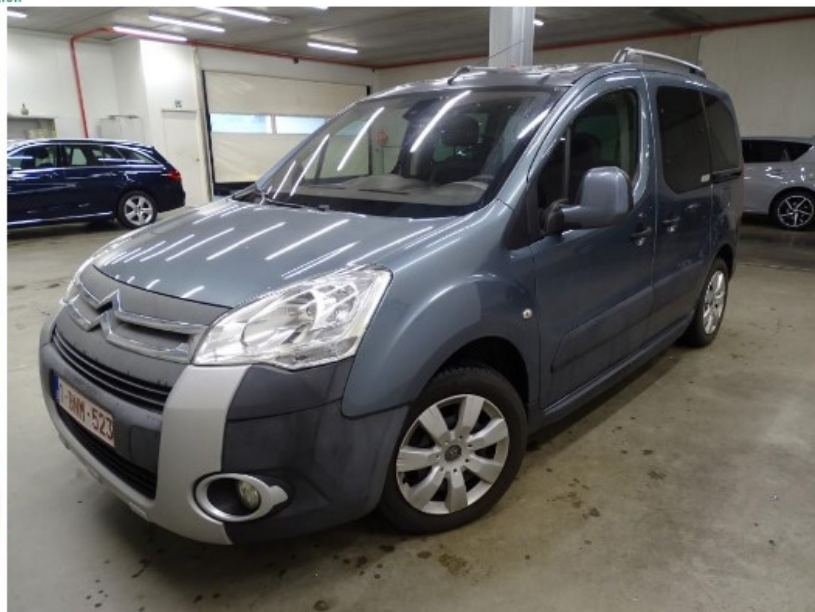
Vinnumber:	<b>VF77J9HP0BJ687626</b>	Versionname:	<b>BERLINGO 2PLC XTR FAP 92PK</b>
First Registrationdate:	<b>11/07/2011</b>	Fiscalpower:	
Expertise Mileage:	<b>118168</b>	Power Kw:	<b>68</b>
Bodytype:		Body color:	<b>Dark Blue</b>
Gearbox:	<b>MAN 5 VIT</b>	Paint type:	<b>Metalic</b>
Transmission:	<b>Front</b>	Rims summer:	<b>Steel</b>
Fueltype:	<b>Diesel</b>	Oil level:	<b>OK</b>
Battery functioning:	<b>Yes</b>	Parking lot:	<b>2402</b>
Number of doors:	<b>5</b>		
Number of seats:	<b>5</b>		
Number head rests:	<b>5</b>		
Rims summer:	<b>Steel</b>		
Category:	<b>Passenger Car</b>		
Oil level:	<b>OK</b>
