AUDI A3 BERLINE: 1LLA109

Limited Technical Inspection

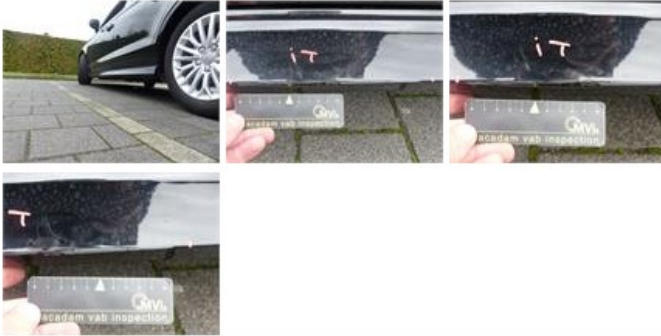
Wing R R, Dent(s) and scratch(es), Acceptable	0,00
<i>No pictures to display</i>	
Rear bulkhead lining, Scratch(es), Acceptable	0,00
<i>No pictures to display</i>	
Seat F L compl, Worn, Acceptable	0,00
<i>No pictures to display</i>	
Door R L, Scratch(es), Acceptable	0,00
<i>No pictures to display</i>	
Alloy rim F R, Scratch(es), Acceptable	0,00
<i>No pictures to display</i>	
Bumper R, Dent(s) and scratch(es), Acceptable	0,00
<i>No pictures to display</i>	
Sill trim L, Scratch(es), It - Spot repair	115,56

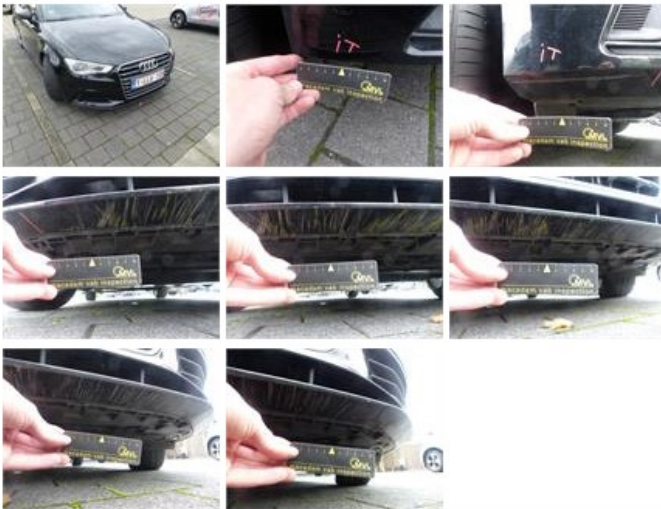
Steering wheel, Worn, Acceptable	0,00
<i>No pictures to display</i>	
Outer door handle F R, Scratch(es), Acceptable	0,00
<i>No pictures to display</i>	
Door F R, Scratch(es), Acceptable	0,00
<i>No pictures to display</i>	
Bumper F, Scratch(es), It - Spot repair	115,56
