**MERCEDES C COUPE: ZM8140**

**Limited Technical Inspection**

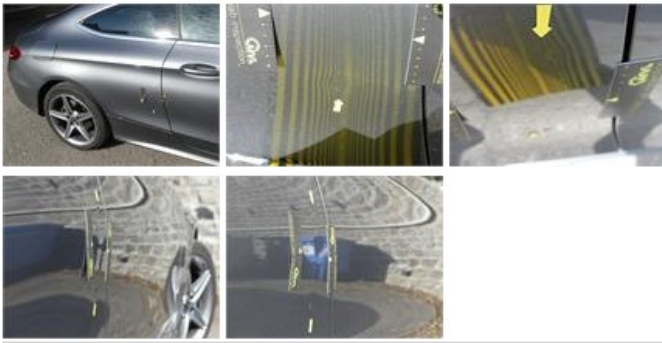
Wing R R, Dent(s), LI - Repair and paint (complete)		356,20
---	--	--------

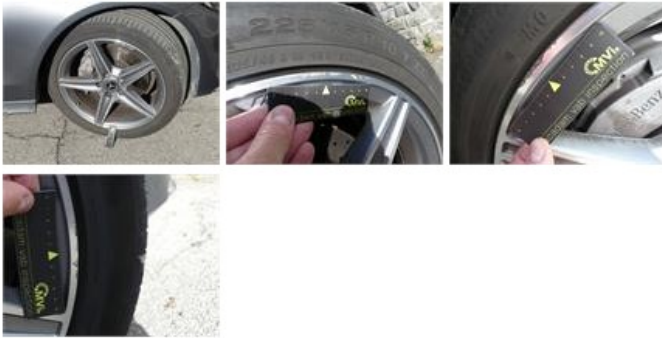
Bonnet, Stone chip(s), Acceptable	0,00
<i>No pictures to display</i>	
Door F R, Dent(s), Acceptable	0,00
<i>No pictures to display</i>	
Alloy rim F R polished, Scratch(es), LI - Repair and paint (complete)	95,00
