<b>BMW 1 HATCH: 1KNP217</b>			
Vinnumber:	<b>WBA1V710105A57453</b>	Versionname:	<b>1.5 116D (85KW)</b>
First Registrationdate:	<b>3/06/2015</b>	Fiscalpower:	
Expertise Mileage:	<b>169132</b>	Power Kw:	<b>85</b>
Bodytype:		Body color:	<b>Silver</b>
Gearbox:	<b>MAN 6 VIT</b>	Paint type:	<b>Metalic</b>
Transmission:	<b>Back</b>	Rims summer:	<b>Aluminium</b>
Fueltype:	<b>Diesel</b>	Oil level:	<b>OK</b>
Battery functioning:	<b>Yes</b>	Parking lot:	<b>4401</b>
Number of doors:	<b>5</b>		
Number of seats:	<b>5</b>		
Number head rests:	<b>5</b>		
Rims summer:	<b>Aluminium</b>		
Category:	<b>Passenger Car</b>		
Oil level:	<b>OK</b>		
Registration Certificate Car (BE):	<b>Yes</b>

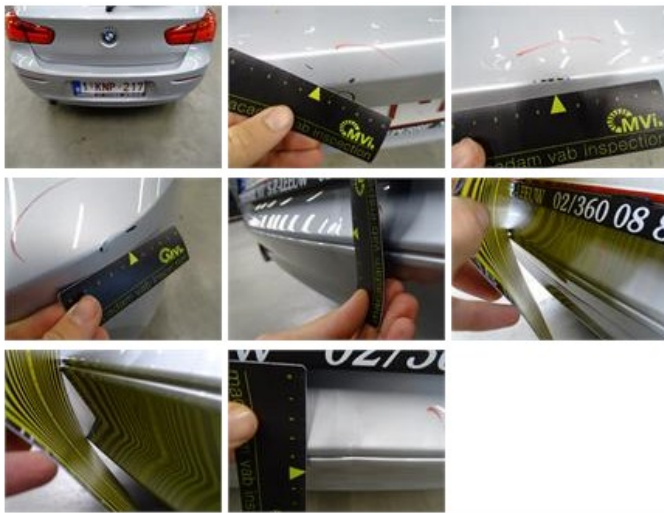
<b>Total cost ex VAT</b>	<b>306,80</b>
<b>Door R R, Scratch(es), Acceptable</b>	<b>0,00</b>
<i>No pictures to display</i>	
<b>Bumper R, Dent(s) and scratch(es), LI - Repair and paint (complete)</b>	<b>211,80</b>
