BMW 2 GRAN TOURER: 1LDS201

Limited Technical Inspection

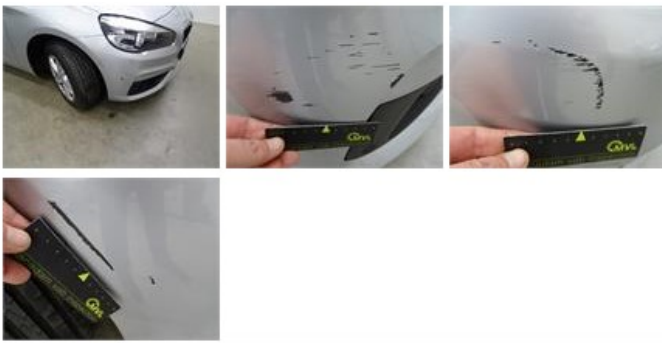
Total cost ex VAT	390,80
Bumper R, Scratch(es), Acceptable	0,00
<i>No pictures to display</i>	
Bumper F, Scratch(es), LI - Repair and paint (complete)	211,80
