MERCEDES C: 1JGR862

Limited Technical Inspection

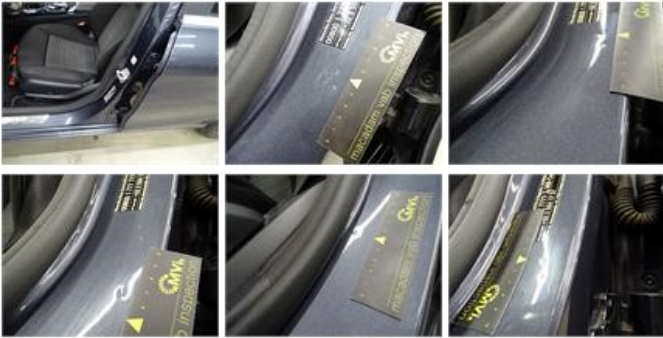
Tailgate, Scratch(es), Acceptable	0,00
<i>No pictures to display</i>	
Bonnet, Stone chip(s), Acceptable	0,00
<i>No pictures to display</i>	
Rocker panel inner F L, Dent(s), LI - Repair and paint (complete)	115,56
