BMW 5 TOURING: 1LGY642

Limited Technical Inspection

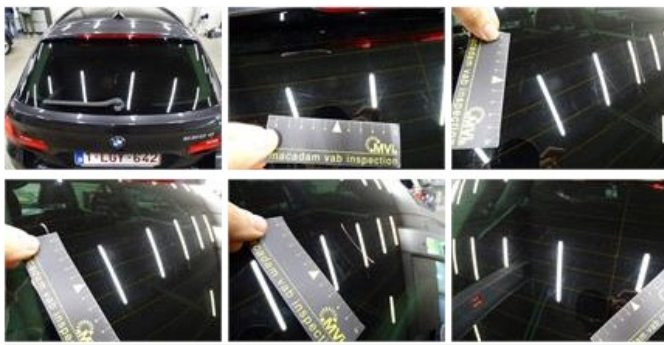
Total cost ex VAT	2062,94
Rear window, Scratch(es), E - Replace	420,00

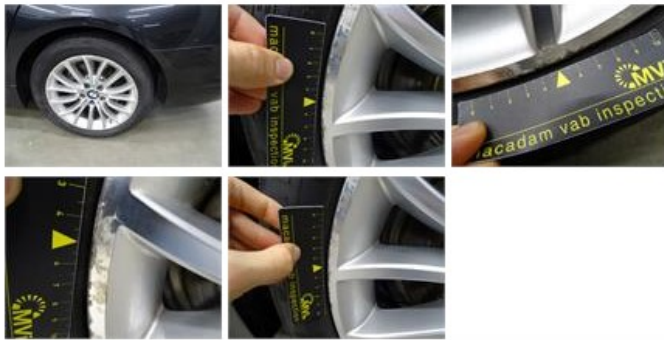
Rear spoiler, Scratch(es), Acceptable	0,00
<i>No pictures to display</i>	
Door F L, Scratch(es), Acceptable	0,00
<i>No pictures to display</i>	
Alloy rim R L polished, Scratch(es), LI - Repair and paint (complete)	95,00

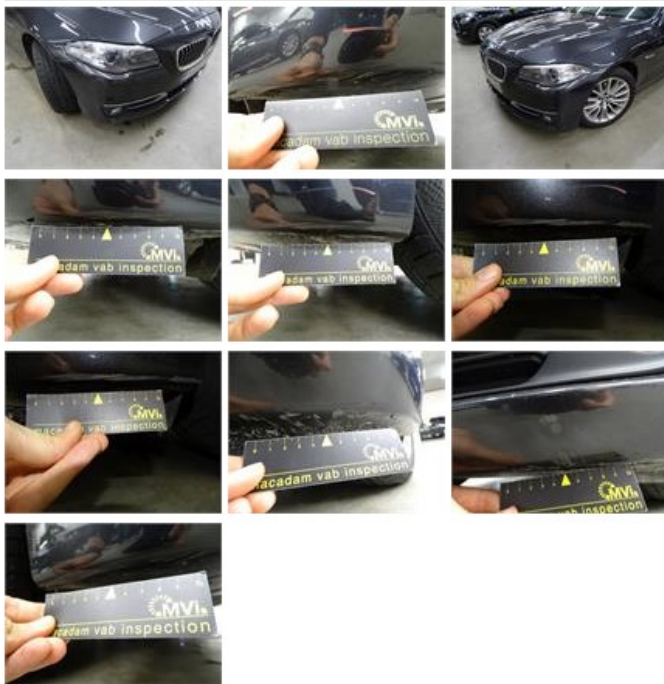
Bumper F, Scratch(es), LI - Repair and paint (complete)	254,16
---	--------

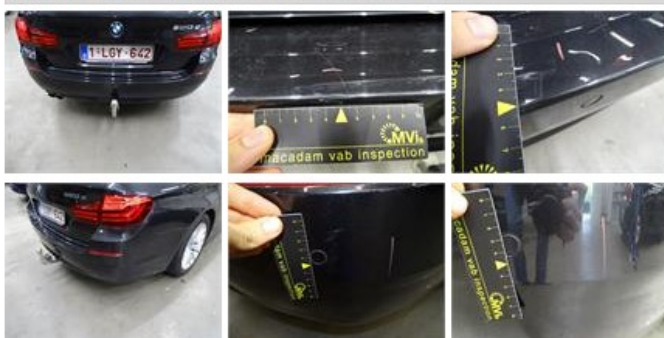
Door F R, Scratch(es), 67 - Polish	0,00
<i>No pictures to display</i>	
Wing R L, Scratch(es), Acceptable	0,00
<i>No pictures to display</i>	
Bumper R, Scratch(es), LI - Repair and paint (complete)	254,16
