MERCEDES C BREAK: 1LCN264

Limited Technical Inspection

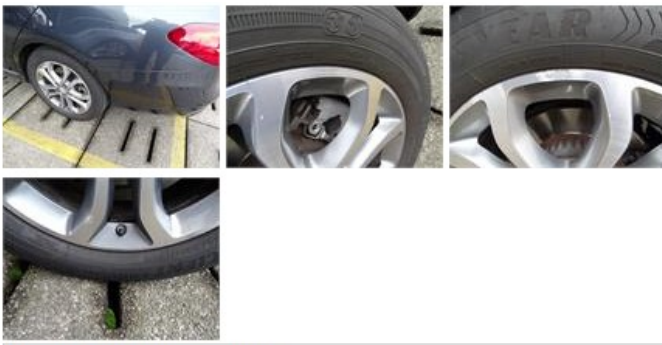
Alloy rim R L polished, Scratch(es), LI - Repair and paint (complete)	95,00
-----------------------------------------------------------------------	--------------

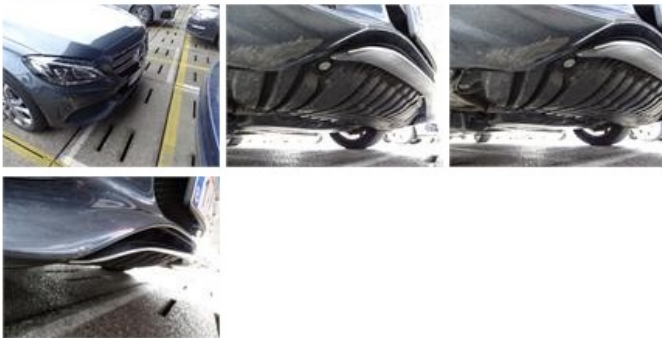
Bumper F L, Scratch(es), Acceptable	0,00
<i>No pictures to display</i>	
Bumper F R, Scratch(es), It - Spot repair	115,56

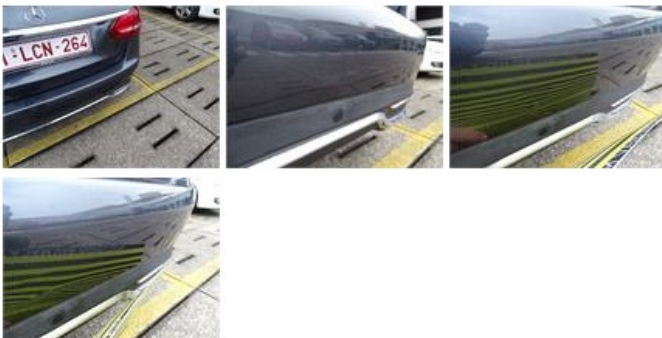
Maintenance, Maintenance, Execute	0,00
<i>No pictures to display</i>	
Mirror side blinker R, Scratch(es), Acceptable	0,00
<i>No pictures to display</i>	
Bumper R, Dent(s) and scratch(es), LI - Repair and paint (complete)	211,80
