AUDI A6: 1HYJ727

Limited Technical Inspection

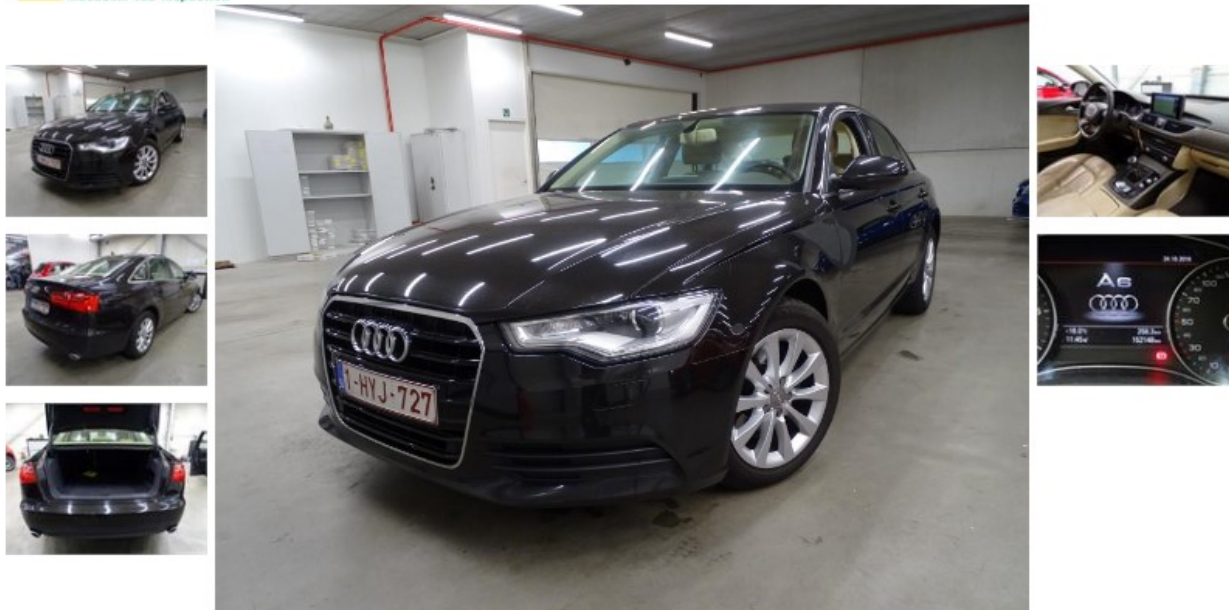
Vinnumber:	WAUZZZ4G6EN203880	Versionname:	A6 BER Ultra 190PK
First Registrationdate:	29/10/2014	Fiscalpower:	
Expertise Mileage:	152148	Power Kw:	140
Bodytype:		Body color:	Brown
Gearbox:	MAN 6 VIT	Paint type:	Metalic
Transmission:	Front	Rims summer:	Aluminium
Fueltype:	Diesel	Oil level:	OK
Maintenance:	OK	Parking lot:	2104
Battery functioning:	Yes		
Number of doors:	4		
Number of seats:	5		
Number head rests:	5		
Rims summer:	Aluminium		
Category:	Passenger Car		
Oil level:	OK		
Registration Certificate Car (BE):	Yes
