PEUGEOT 308 SW: 1LGY146

Limited Technical Inspection

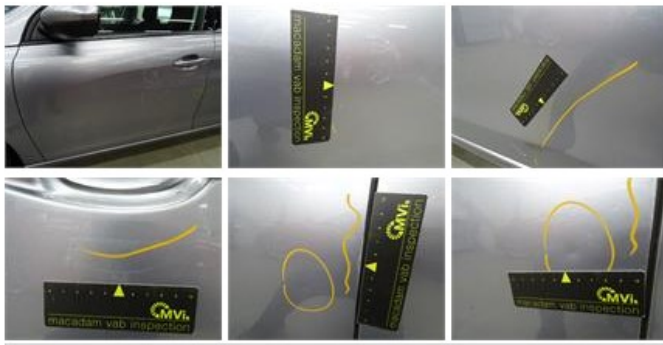
Repair kit	Yes	Compressor	Yes
Total cost ex VAT			608,35
Roof, Dent(s), Acceptable			0,00
<i>No pictures to display</i>			
Alloy rim R L, Scratch(es), Acceptable			0,00
<i>No pictures to display</i>			
Door F L, Dent(s) and scratch(es), LI - Repair and paint (complete)			318,35

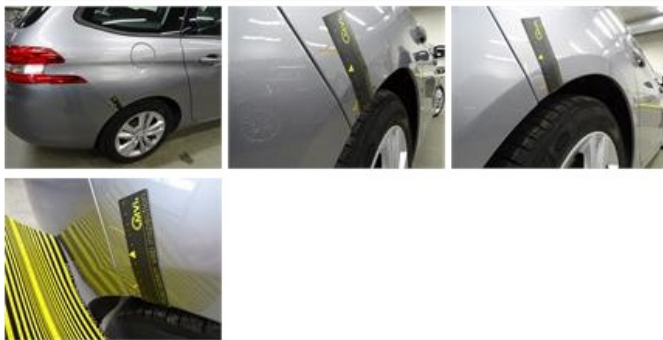
Wing R R, Dent(s), PDR - Paintless dent repair	63,00
--	-------
