RENAULT CLIO: 1LSL004

Limited Technical Inspection

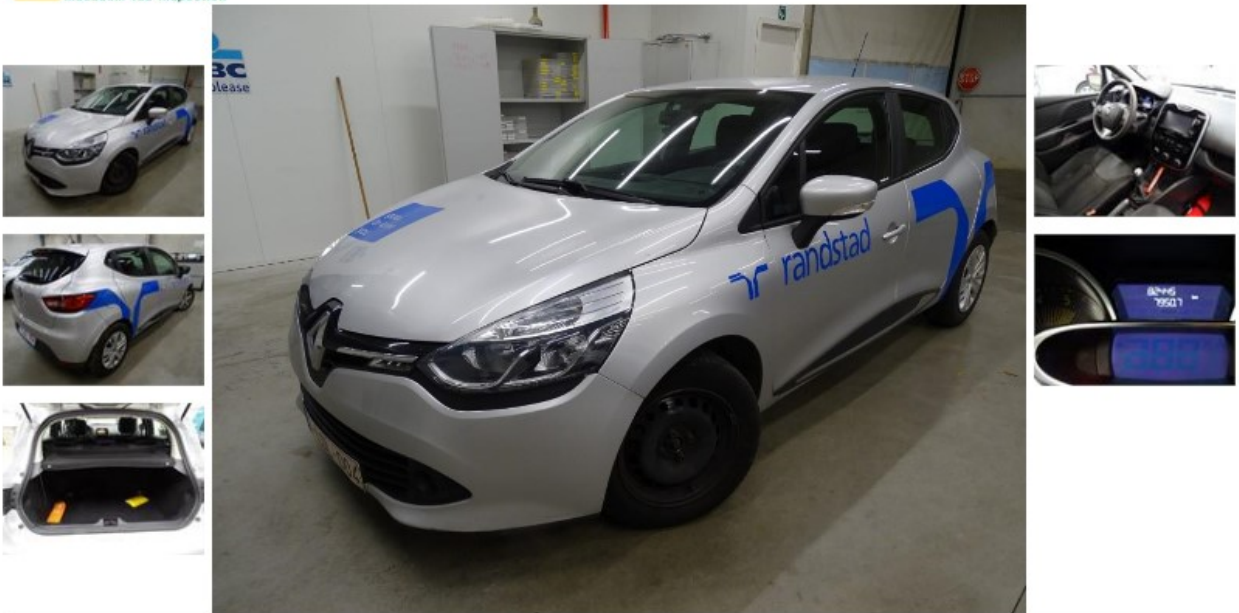
Vinnumber:	VF15R0J0A54168256	Versionname:	1.5 ENERGY DCI 90E EXPRESSION
First Registrationdate:	24/11/2015	Fiscalpower:	
Expertise Mileage:	82445	Power Kw:	66
Bodytype:		Body color:	Silver
Gearbox:	MAN 5 VIT	Paint type:	Metallic
Transmission:	Front	Rims summer:	Steel
Fueltype:	Diesel	Oil level:	OK
Battery functioning:	Yes	Parking lot:	2831
Number of doors:	5		
Number of seats:	5		
Number head rests:	5		
Rims summer:	Steel		
Category:	Passenger Car		
Oil level:	OK		
Registration Certificate Car (BE):	Yes
