**VOLKSWAGEN Golf: 1HXX422**

**Limited Technical Inspection**

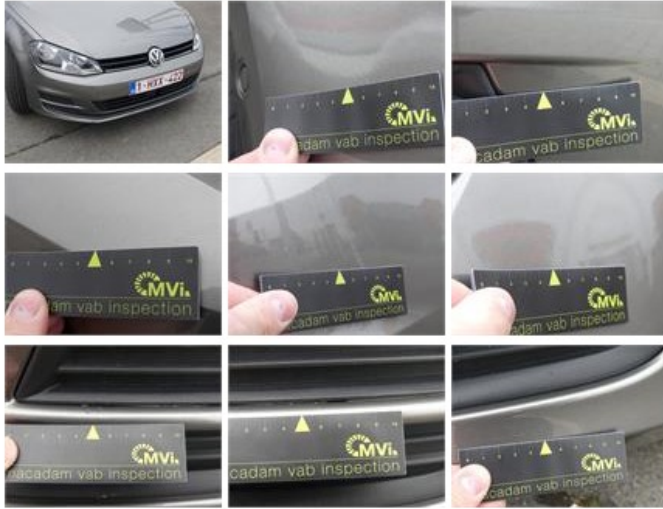
<i>No pictures to display</i>	
Bumper R, Dent(s) and scratch(es), Acceptable	0,00
<i>No pictures to display</i>	
Door F L, Scratch(es), Acceptable	0,00
<i>No pictures to display</i>	
Door R L, Scratch(es), Acceptable	0,00
<i>No pictures to display</i>	
Wing F R, Dent(s) and scratch(es), Acceptable	0,00
<i>No pictures to display</i>	
Bumper F, Bad repair, LI - Repair and paint (complete)	0,00
