VOLKSWAGEN Golf: 1HXX367

Limited Technical Inspection

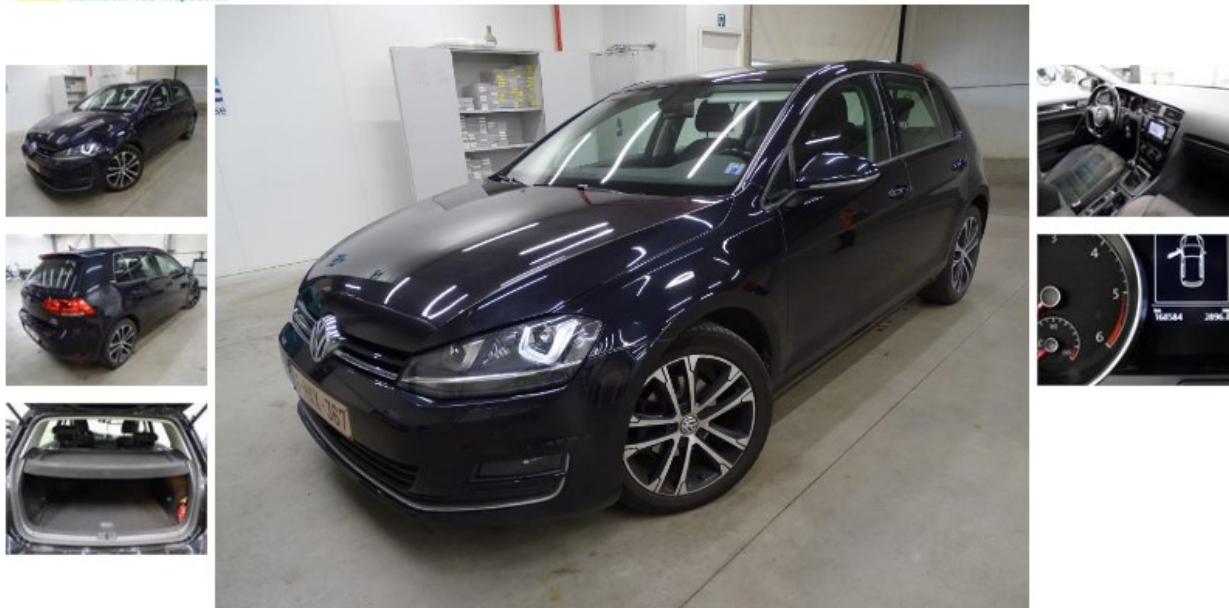
Vinnumber:	WVWZZZAUZFP035635	Versionname:	GOLF BER Highline 105PK
First Registrationdate:	24/10/2014	Fiscalpower:	
Expertise Mileage:	168584	Power Kw:	77
Bodytype:		Body color:	Black
Gearbox:	MAN 5 VIT	Paint type:	Metalic
Transmission:	Front	Rims summer:	Aluminium
Fueltype:	Diesel	Oil level:	OK
Battery functioning:	Yes	Parking lot:	2630
Number of doors:	5		
Number of seats:	5		
Number head rests:	5		
Rims summer:	Aluminium		
Category:	Passenger Car		
Oil level:	OK		
Registration Certificate Car (BE):	Yes
