**VOLKSWAGEN PASSAT VARIANT: 1PNU196**

**Limited Technical Inspection**

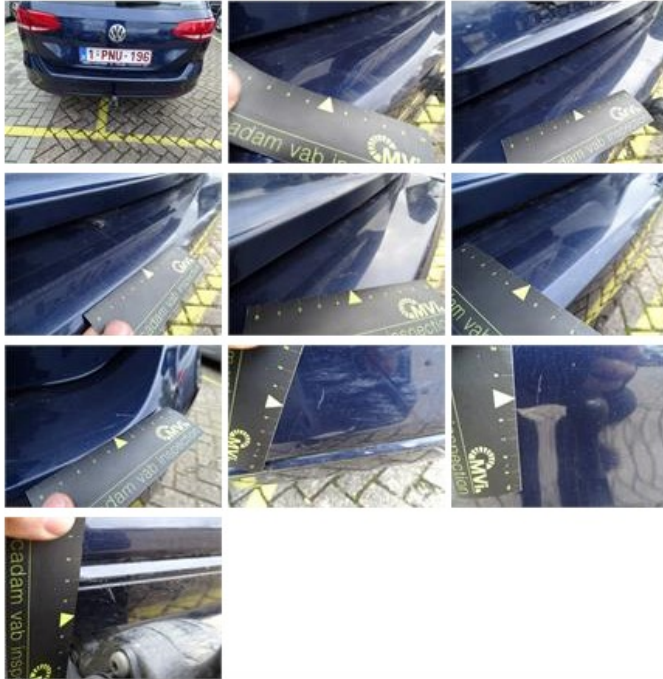
Bumper R, Scratch(es), LI - Repair and paint (complete)	211,80
---	--------

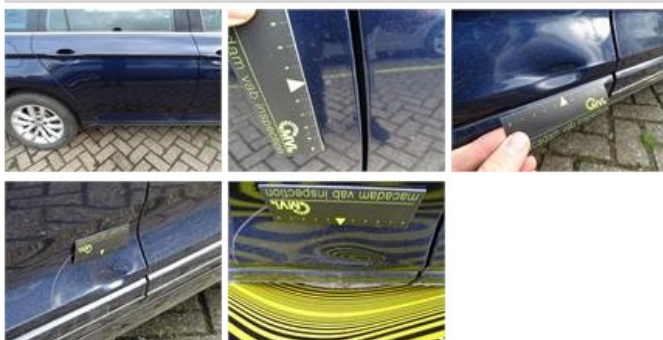
Tailgate, Scratch(es), Acceptable	0,00
<i>No pictures to display</i>	
Bumper F, Scratch(es), Acceptable	0,00
<i>No pictures to display</i>	
Wing F L, Scratch(es), Acceptable	0,00
<i>No pictures to display</i>	
Door R L, Scratch(es), Acceptable	0,00
<i>No pictures to display</i>	
Door R R, Dent(s) and scratch(es), LI - Repair and paint (complete)	318,35
