VOLVO XC60: 1LEG969

Limited Technical Inspection

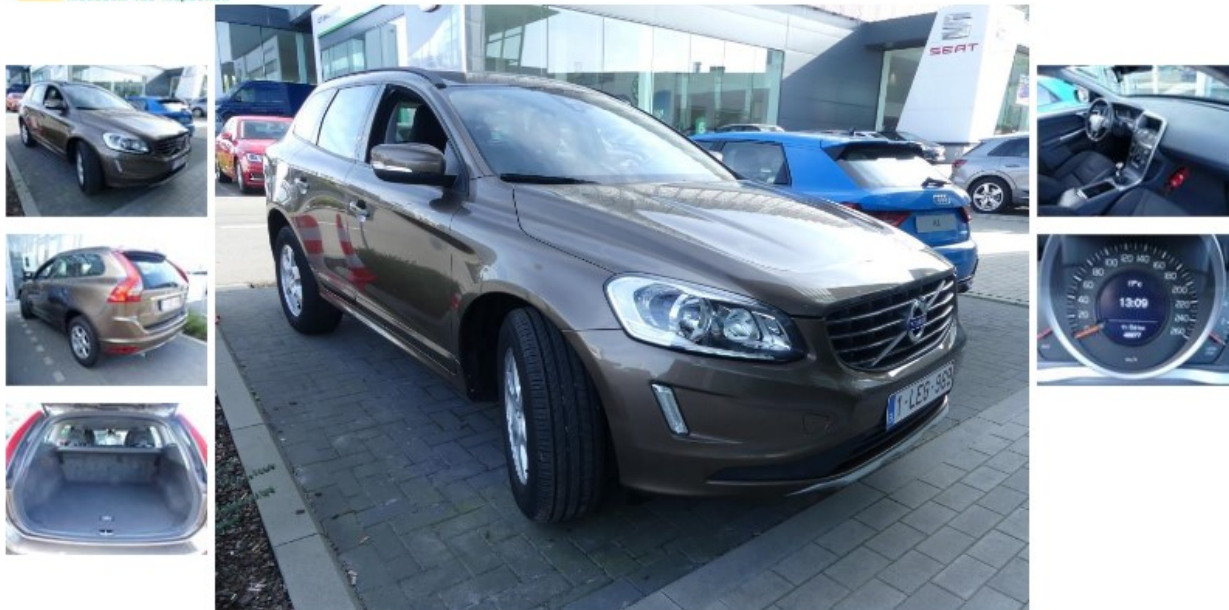
Vinnumber:	VV1DZARC1G2821782	Versionname:	2.0 D3 2WD KINETIC
First Registrationdate:	4/09/2015	Fiscalpower:	
Expertise Mileage:	48877	Power Kw:	110
Bodytype:		Body color:	Brown
Gearbox:	MAN 6 VIT	Paint type:	Metalic
Transmission:	Front	Rims summer:	Aluminium
Fueltype:	Diesel	Oil level:	OK
Maintenance:	NOT OK	Parking lot:	2604
Maintenance:	SINDS 0 KM		
Battery functioning:	Yes		
Number of doors:	5		
Number of seats:	5		
Number head rests:	5		
Rims summer:	Aluminium		
Category:	Passenger Car		
Oil level:	OK		
Registration Certificate Car (BE):	Yes
