AUDI a3 Limousine: UK8799

Limited Technical Inspection

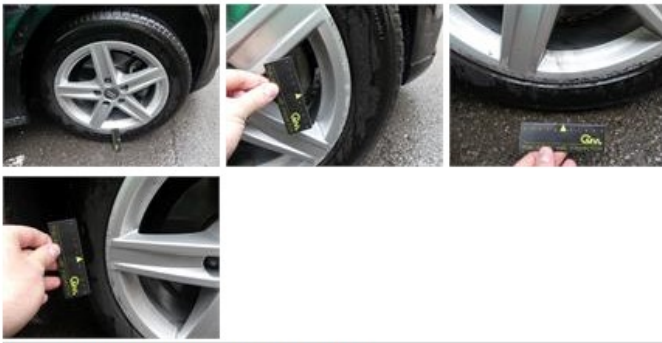
Emergency spare wheel	Yes	Jack	Yes
Total cost ex VAT			427,16
Alloy rim F R, Scratch(es), LI - Repair and paint (complete)			95,00
