MERCEDES GLA: 1HFB589

Limited Technical Inspection

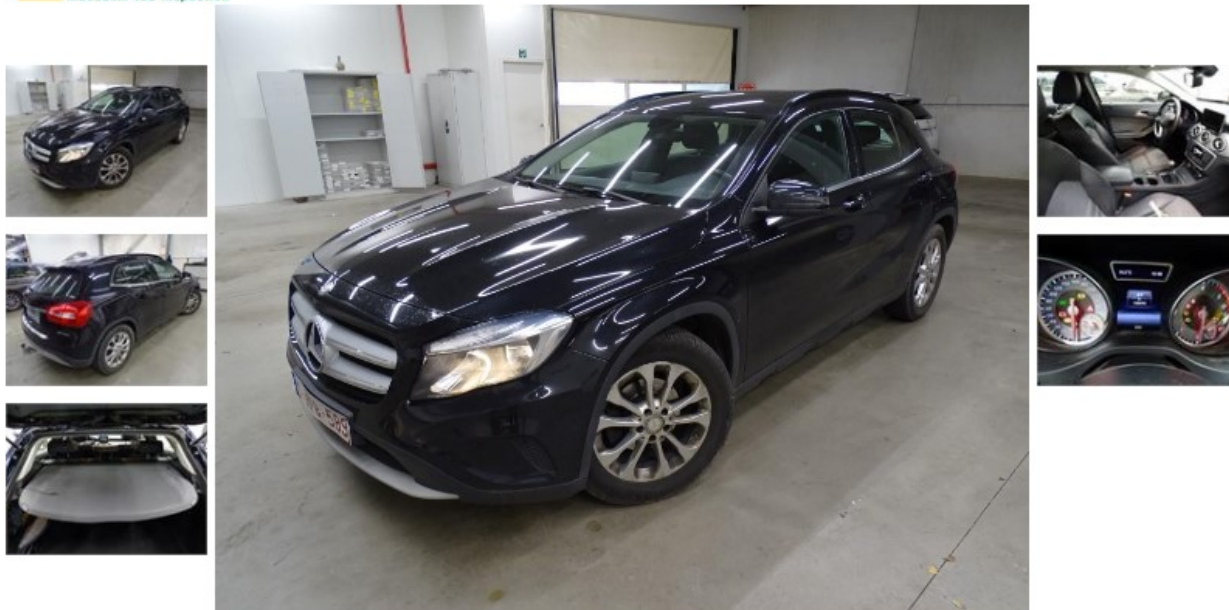
Vinnumber:	WDC1569081J021408	Versionname:	GLA 200 CDI 136PK
First Registrationdate:	4/07/2014	Fiscalpower:	
Expertise Mileage:	168696	Power Kw:	100
Bodytype:		Body color:	Black
Gearbox:	MAN 6 VIT	Paint type:	Metalic
Transmission:	Back	Rims summer:	Aluminium
Fueltype:	Diesel	Oil level:	OK
Battery functioning:	Yes	Parking lot:	4203
Number of doors:	5		
Number of seats:	5		
Number head rests:	5		
Rims summer:	Aluminium		
Category:	Passenger Car		
Oil level:	OK		
Registration Certificate Car (BE):	Yes
