BMW 5 BERLINE: 1KFJ350

Limited Technical Inspection

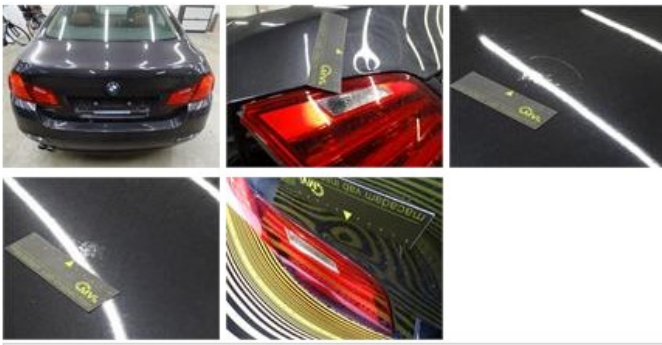
Total cost ex VAT	559,72
Bumper F, Scratch(es), Acceptable	0,00
<i>No pictures to display</i>	
Tailgate, Dent(s), It - Spot repair	115,56

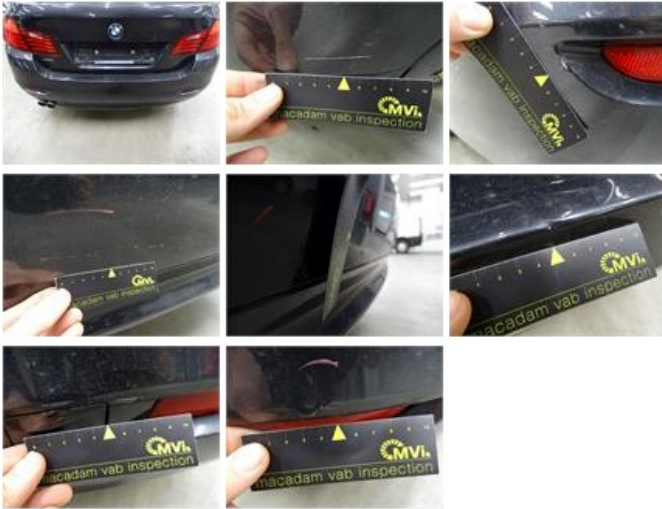
Door F R, Scratch(es), Acceptable	0,00
<i>No pictures to display</i>	
Roof, Dent(s), Acceptable	0,00
<i>No pictures to display</i>	
Rearview mirror housing L, Scratch(es), Acceptable	0,00
<i>No pictures to display</i>	
Bumper R, Dent(s) and scratch(es), LI - Repair and paint (complete)	254,16

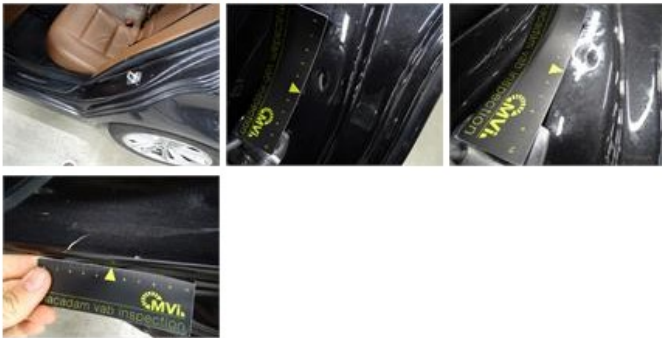
Door frame R L, Scratch(es), Acceptable	0,00
---	------

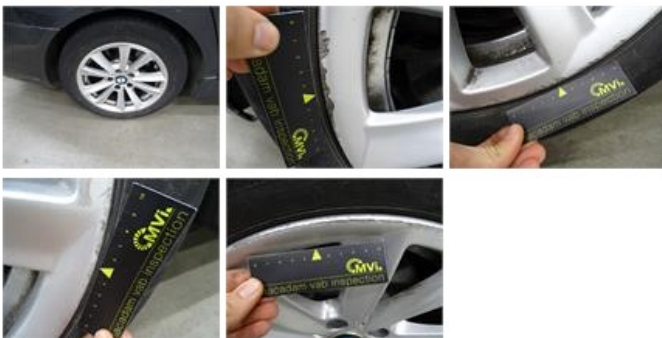
<i>No pictures to display</i>	
Door F L, Scratch(es), Acceptable	0,00
<i>No pictures to display</i>	
Bonnet, Chemical polution, 67 - Polish	0,00
<i>No pictures to display</i>	
Alloy rim R L, Scratch(es), Acceptable	0,00
<i>No pictures to display</i>	
Alloy rim R R, Scratch(es), LI - Repair and paint (complete)	95,00

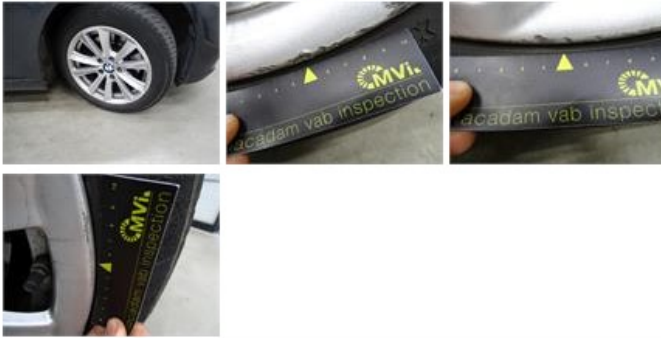
Alloy rim F R, Scratch(es), LI - Repair and paint (complete)

95,00
