BMW 2 GRAN TOURER: GL9447

Limited Technical Inspection

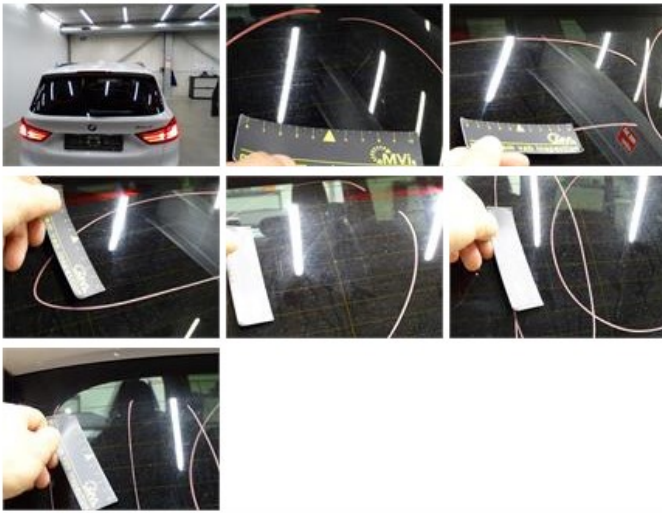
Runflat	Yes
Total cost ex VAT		700,20
Alloy rim F R polished, Rust, Acceptable		0,00
<i>No pictures to display</i>		
Rear window, Scratch(es), E - Replace		370,00

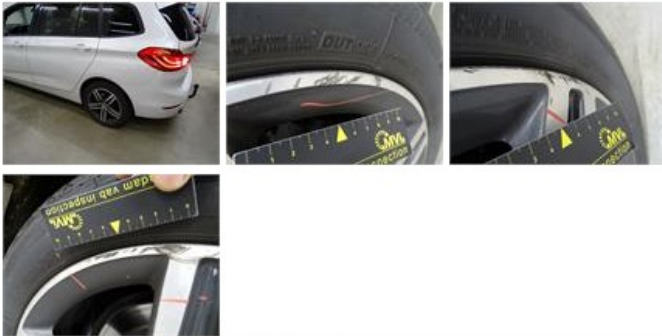
Alloy rim R L polished, Scratch(es), LI - Repair and paint (complete) 95,00
