BMW X3: 1NKF413

Limited Technical Inspection

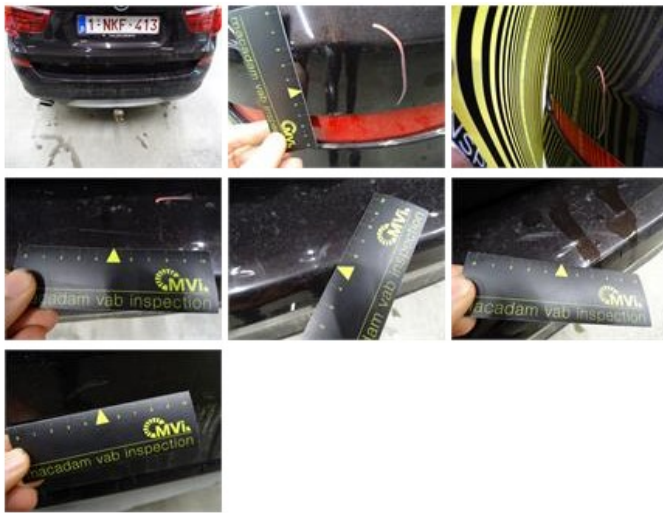
Total cost ex VAT	1235,18
Bumper R, Dent(s) and scratch(es), LI - Repair and paint (complete)	254,16

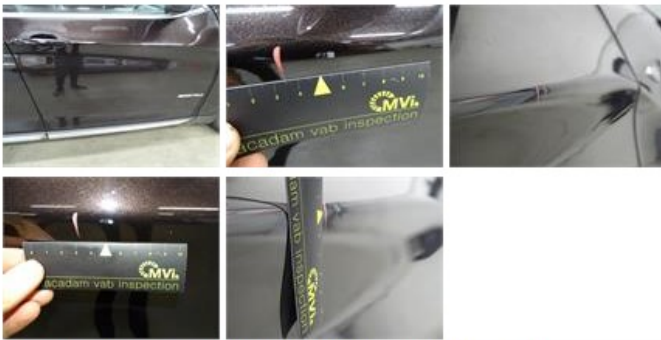
Door F L, Scratch(es), Acceptable	0,00
<i>No pictures to display</i>	
Windscreen, Scratch(es), Acceptable	0,00
<i>No pictures to display</i>	
Door R L, Scratch(es), Acceptable	0,00
<i>No pictures to display</i>	
Bumper F, Scratch(es), Acceptable	0,00
<i>No pictures to display</i>	
Wing R R, Scratch(es), Acceptable	0,00
<i>No pictures to display</i>	
Door R R, Scratch(es), 67 - Polish	0,00
<i>No pictures to display</i>	
Door F R, Dent(s) and scratch(es), LI - Repair and paint (complete)	382,02

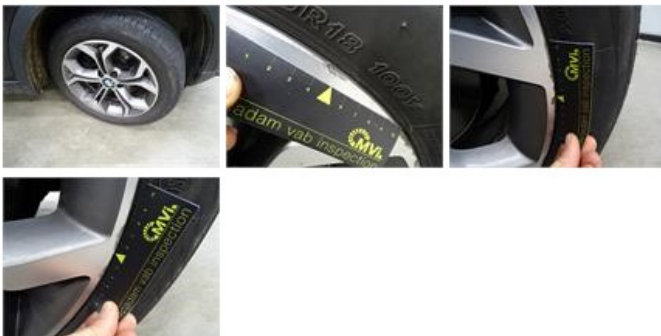
Alloy rim F R polished, Scratch(es), LI - Repair and paint (complete)	95,00
---	-------

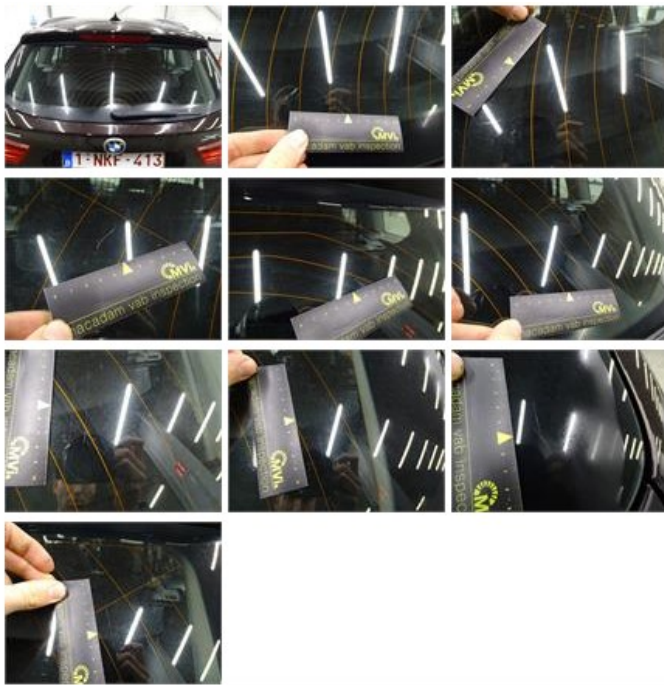
Trunk lid covering R, Scratch(es), Acceptable	0,00
<i>No pictures to display</i>	
Rear window, Scratch(es), E - Replace	420,00
