FORD MONDEO: 1LNE921

Limited Technical Inspection

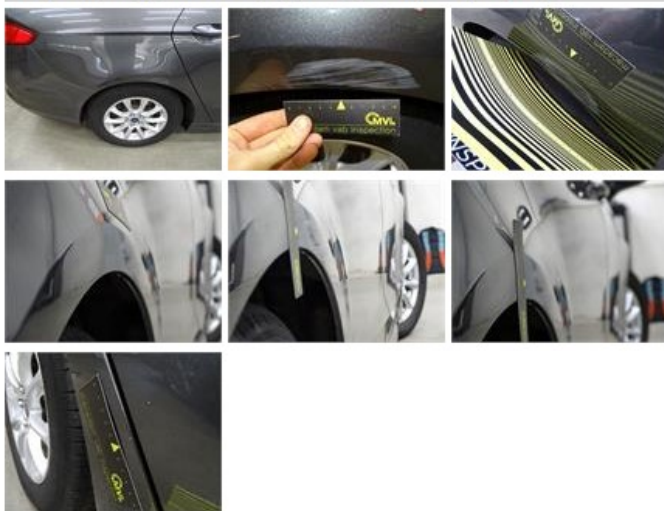
Door R L, Scratch(es), Acceptable	0,00
<i>No pictures to display</i>	
Door F R, Repaired, Acceptable	0,00
<i>No pictures to display</i>	
Door F L, Scratch(es), Acceptable	0,00
<i>No pictures to display</i>	
Bumper F, Scratch(es), Acceptable	0,00
<i>No pictures to display</i>	
Wing R L, Dent(s) and scratch(es), Acceptable	0,00
<i>No pictures to display</i>	
Bonnet, Repaired, Acceptable	0,00
<i>No pictures to display</i>	
Floor covering F L, Hole, Smart repair	64,32

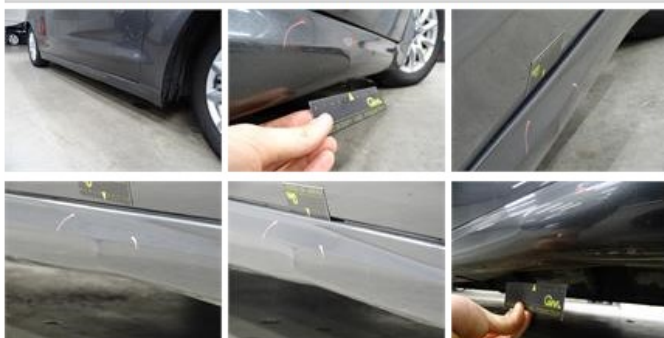
Sill outer R, Dent(s) and scratch(es), LI - Repair and paint (complete)	310,50
---	--------
