**MERCEDES C: 1JPV046**

**Limited Technical Inspection**

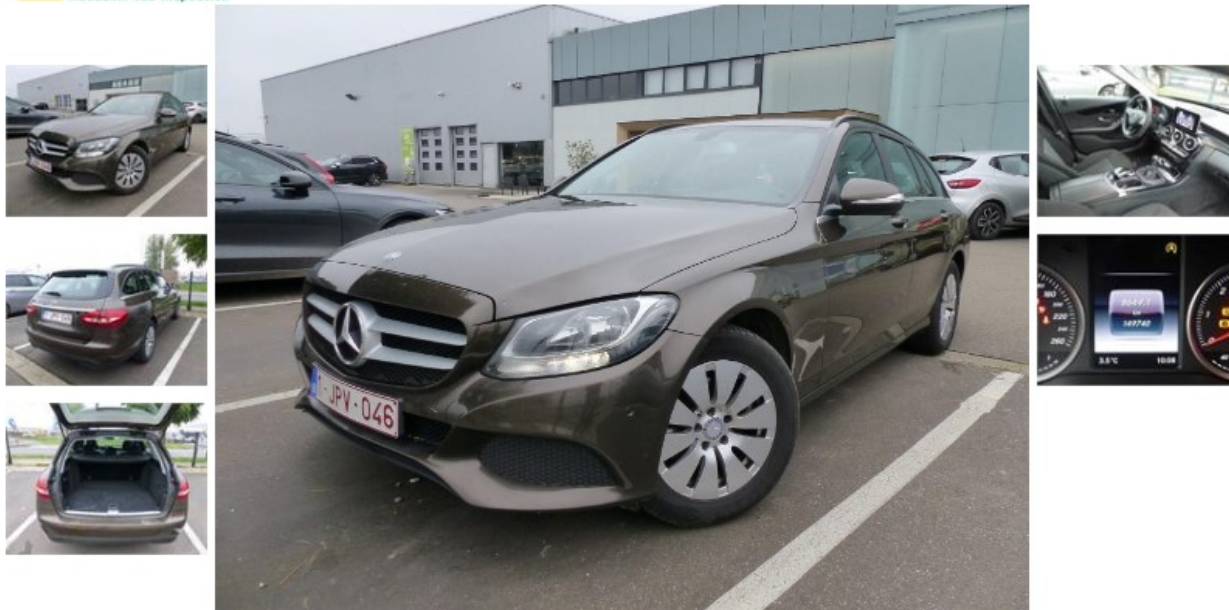
Vinnumber:	<b>WDD2052361F130550</b>	Versionname:	<b>C BRE 180 BlueTEC 116PK</b>
First Registrationdate:	<b>3/02/2015</b>	Fiscalpower:	
Expertise Mileage:	<b>149740</b>	Power Kw:	<b>85</b>
Bodytype:		Body color:	<b>Brown</b>
Gearbox:	<b>MAN 6 VIT</b>	Paint type:	<b>Metalic</b>
Transmission:	<b>Back</b>	Rims summer:	<b>Aluminium</b>
Fueltype:	<b>Diesel</b>	Oil level:	<b>OK</b>
Maintenance:	<b>OK</b>	Parking lot:	<b>LCV</b>
Maintenance:	<b>A3 IN 20900 KM</b>		
Battery functioning:	<b>Yes</b>		
Number of doors:	<b>5</b>		
Number of seats:	<b>5</b>		
Number head rests:	<b>5</b>		
Rims summer:	<b>Aluminium</b>		
Category:	<b>Passenger Car</b>		
Oil level:	<b>OK</b>		
Registration Certificate Car (BE):	<b>Yes</b>
