## VOLVO V60: 1JXT115

## Limited Technical Inspection

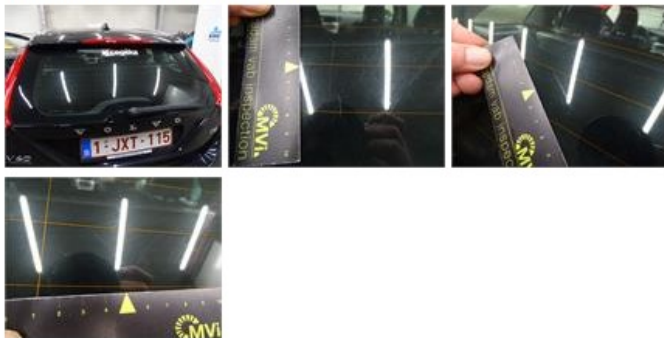
Bumper F, Scratch(es), Acceptable	0,00
<i>No pictures to display</i>	
Backrest cover F L, Worn, Acceptable	0,00
<i>No pictures to display</i>	
Alloy rim R R polished, Scratch(es), Acceptable	0,00
<i>No pictures to display</i>	
Wing R R, Scratch(es), Acceptable	0,00
<i>No pictures to display</i>	
Rear window, Scratch(es), E - Replace	370,00
