BMW 1 HATCH: 1KKF371

Limited Technical Inspection

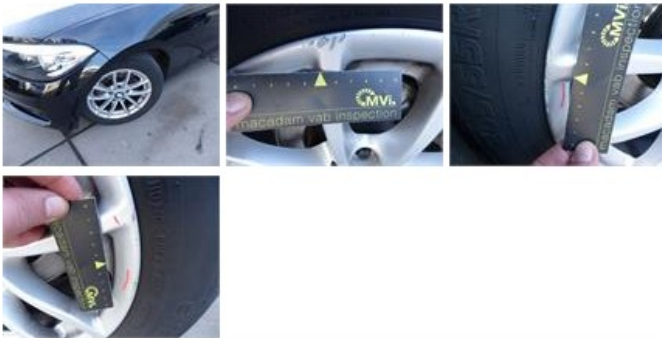
Door F R, Dent(s), Acceptable	0,00
<i>No pictures to display</i>	
Door R L, Scratch(es), Acceptable	0,00
<i>No pictures to display</i>	
Door F L, Scratch(es), Acceptable	0,00
<i>No pictures to display</i>	
Door R R, Dent(s) and scratch(es), Acceptable	0,00
<i>No pictures to display</i>	
Alloy rim F L, Scratch(es), LI - Repair and paint (complete)	95,00

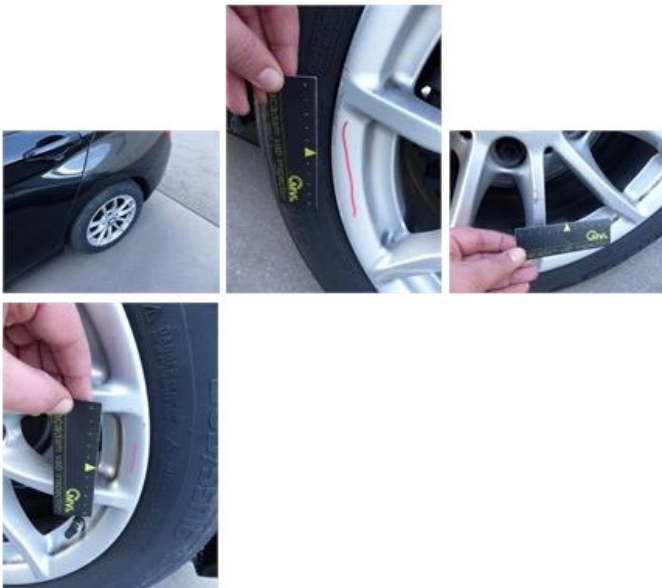
Alloy rim R L, Scratch(es), LI - Repair and paint (complete)	95,00
--	-------
