MERCEDES C180 COUPE: ZM8156

Limited Technical Inspection

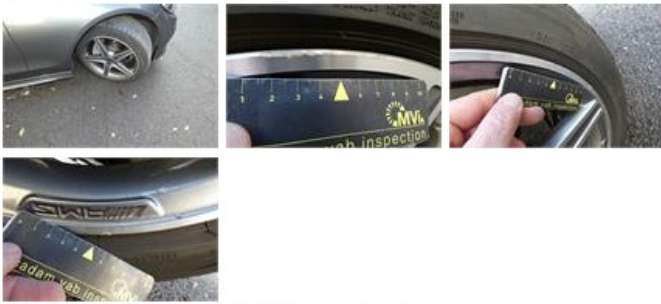
Repair kit	Yes	Compressor	Yes
Total cost ex VAT			195,22
Wing R R, Dent(s), Acceptable			0,00
<i>No pictures to display</i>			
Alloy rim F R polished, Scratch(es), LI - Repair and paint (complete)			95,00
