BMW 1 HATCH: 1LLE571

Limited Technical Inspection

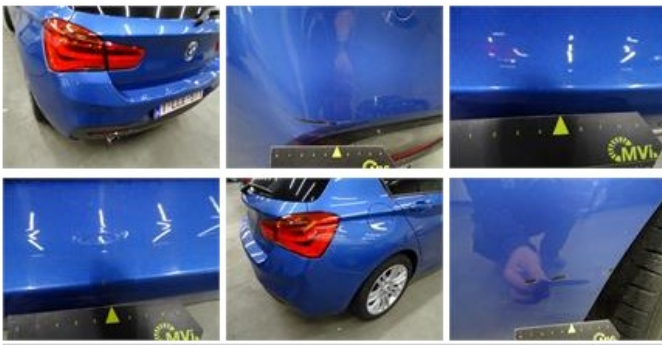
Total cost ex VAT	1057,13
Rear window, Scratch(es), Acceptable	0,00
<i>No pictures to display</i>	
Bumper R, Scratch(es), LI - Repair and paint (complete)	211,80

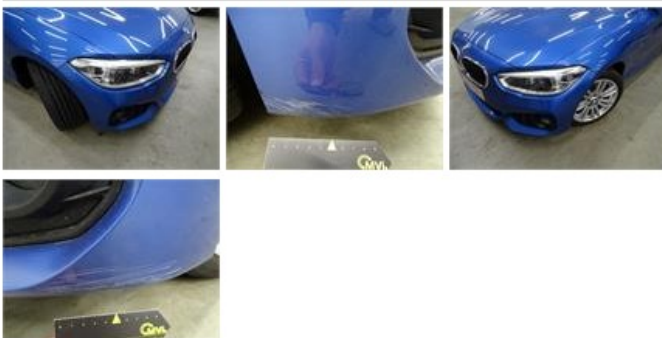
Bumper F, Scratch(es), LI - Repair and paint (complete) 211,80
