**VOLVO V60: 1LB308**

**Limited Technical Inspection**

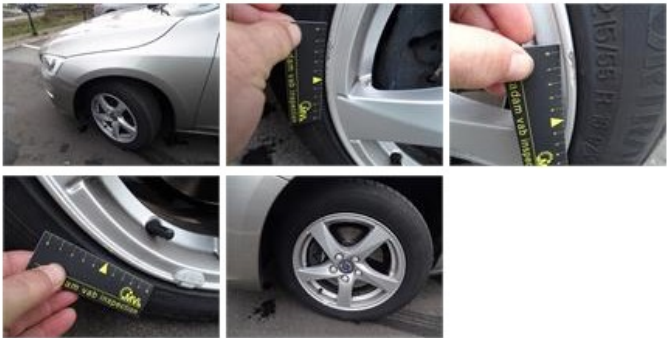
<i>No pictures to display</i>		
Alloy rim R L, Scratch(es), Acceptable		0,00
<i>No pictures to display</i>		
Interior, Dirty, Acceptable		0,00
<i>No pictures to display</i>		
Alloy rim F L, Scratch(es), LI - Repair and paint (complete)		95,00
