MERCEDES GLA: 1KVR440

Limited Technical Inspection

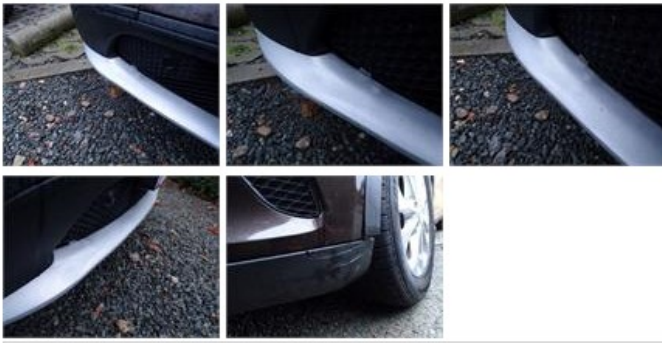
Total cost ex VAT	1023,86
Wing trim R R, Scratch(es), Acceptable	0,00
<i>No pictures to display</i>	
Bumper Trim F, Dent(s) and scratch(es), E - Replace	220,10
