**RENAULT CLIO: 1LLD327**

**Limited Technical Inspection**

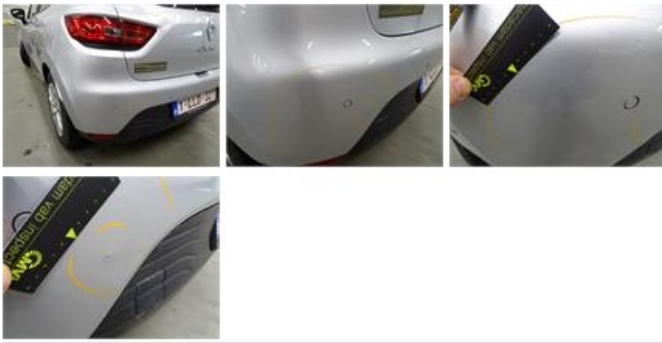
Total cost ex VAT	920,54
Bumper F, Stone chip(s), Acceptable	0,00
<i>No pictures to display</i>	
Wheel cover R R, Scratch(es), Acceptable	0,00
<i>No pictures to display</i>	
Wing R R, Dent(s), Acceptable	0,00
<i>No pictures to display</i>	
Bumper R, Dent(s) and scratch(es), LI - Repair and paint (complete)	169,44

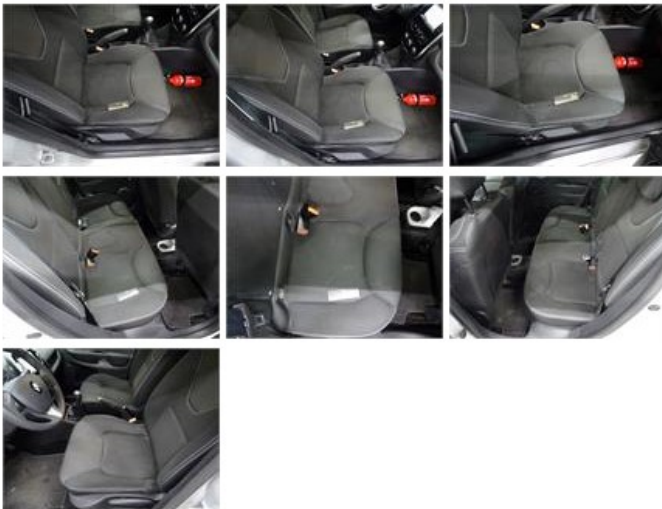
Interior, Dirty, Cleaning 0,00
