**TOYOTA PRIUS: 1PSJ52**

Vinnumber:	<b>JTDKB3FU403530940</b>	Versionname:	<b>1.8 VVT-i Hybrid Lounge</b>
First Registrationdate:	<b>6/09/2016</b>	Fiscalpower:	
Expertise Mileage:	<b>103653</b>	Power Kw:	<b>90</b>
Bodytype:	<b>Hatchback</b>	Body color:	<b>Dark Red</b>
Gearbox:	<b>Automatic</b>	Paint type:	<b>Metalic</b>
Transmission:	<b>Front</b>	Rims summer:	<b>Aluminium</b>
Fueltype:	<b>Hybrid Petrol</b>	Oil level:	<b>OK</b>
Maintenance:	<b>OK</b>	Parking lot:	<b>3204</b>
Battery functioning:	<b>Yes</b>		
Number of doors:	<b>5</b>		
Number of seats:	<b>5</b>		
Number head rests:	<b>5</b>		
Rims summer:	<b>Aluminium</b>		
Category:	<b>Passenger Car</b>		
Oil level:	<b>OK</b>		
Registration Certificate Car (BE):	<b>Yes</b>

**Limited Technical Inspection**

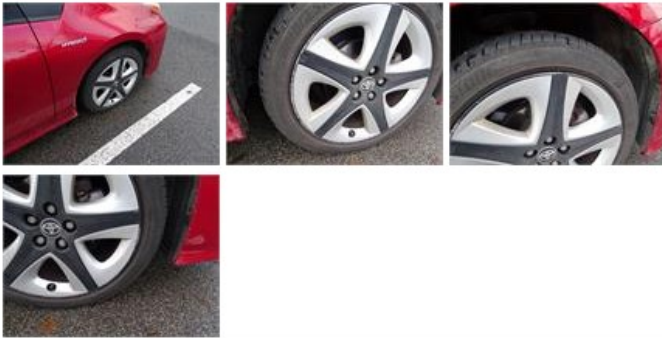
Bumper trim R, Scratch(es), Acceptable	0,00
<i>No pictures to display</i>	
Alloy rim R L, Scratch(es), Acceptable	0,00
<i>No pictures to display</i>	
Alloy rim F L, Scratch(es), Acceptable	0,00
<i>No pictures to display</i>	
Door F R, Dent(s), Acceptable	0,00
<i>No pictures to display</i>	
Door F L, Dent(s), Acceptable	0,00
<i>No pictures to display</i>	
Bumper R, Scratch(es), Acceptable	0,00
<i>No pictures to display</i>	
Alloy rim F R, Scratch(es), LI - Repair and paint (complete)	95,00

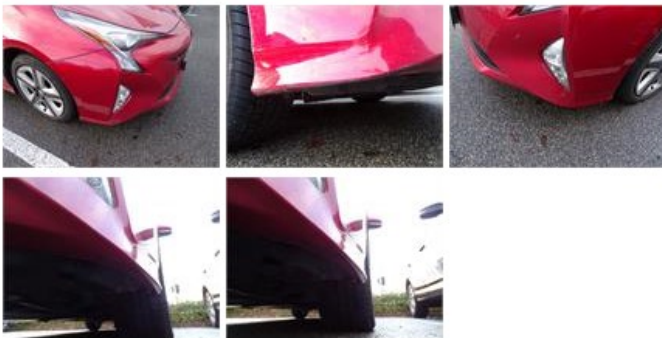
Bumper F, Scratch(es), LI - Repair and paint (complete)	211,80
---	--------
