VOLKSWAGEN TIGUAN: RY6548

Limited Technical Inspection

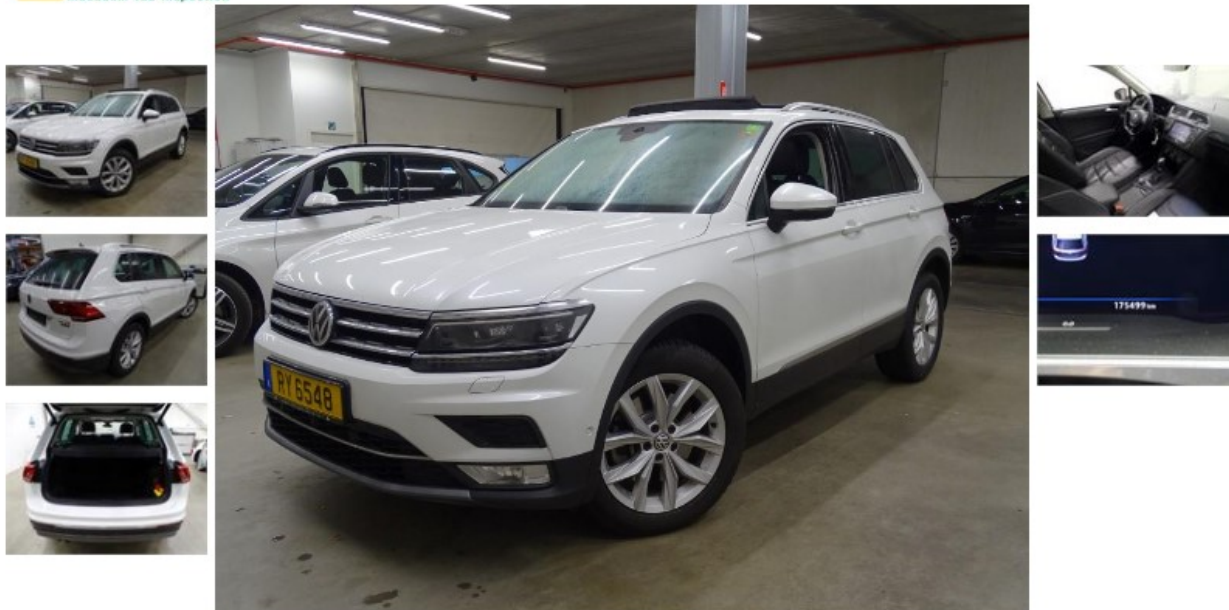
Vinnumber:	WVGZZZ5NZHW823884	Versionname:	2.0 TDI BMT BMT 140KW DSG7 4WD HIGHLINE
First Registrationdate:	18/11/2016	Fiscalpower:	
Expertise Mileage:	175499	Power Kw:	140
Bodytype:		Body color:	White
Gearbox:	Automatic	Paint type:	Opaque
Transmission:	4 Weel	Rims summer:	Aluminium
Fueltype:	Diesel	Oil level:	OK
Battery functioning:	Yes	Parking lot:	3724
Number of doors:	5		
Number of seats:	5		
Number head rests:	5		
Rims summer:	Aluminium		
Category:	Passenger Car		
Oil level:	OK
