BMW 1 HATCH: 1PHN477

Limited Technical Inspection

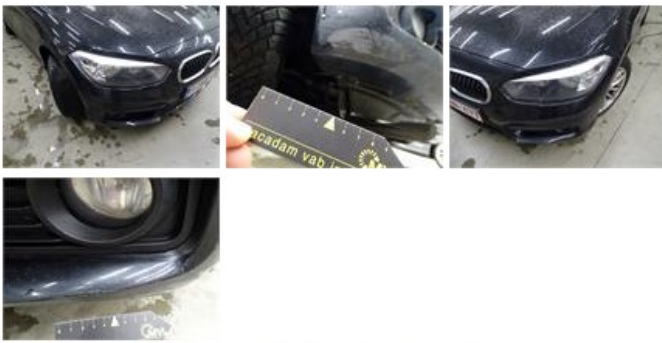
Repair kit	Yes	Compressor	Yes
Total cost ex VAT			1399,47
Bumper F, Scratch(es), LI - Repair and paint (complete)			211,80
